LIMITED-SCOPE ASBESTOS SURVEY REPORT

Minneapolis Public Housing Authority
1314 44th Avenue North (Hamilton Manor)
Minneapolis, Minnesota

Angstrom No.00-0720

July 20th, 2000

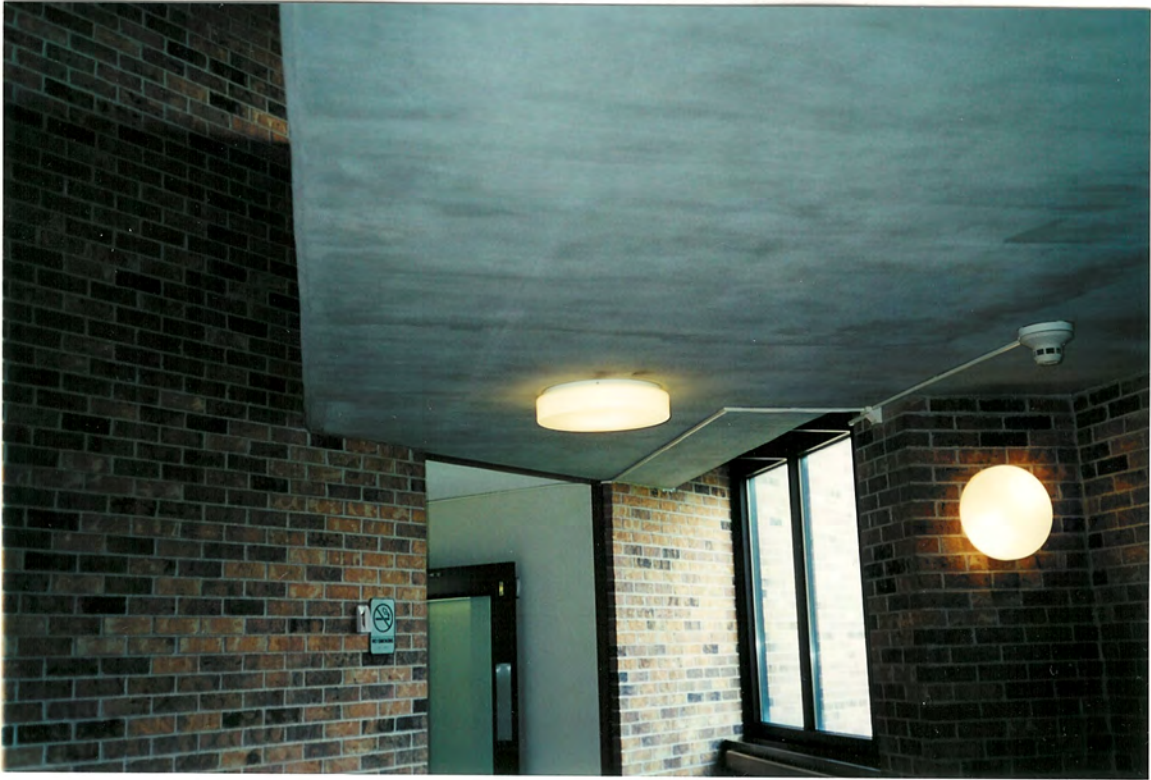
1. Approximately 325 to 350 square feet of ceiling texture in the dwelling units in generally good condition.
2. Approximately 3,000 to 3,500 square feet of ceiling texture in each corridor in generally good condition.
3. Approximately 30 to 40 square feet of ceiling texture in the janitor's closets on each floor in generally good condition.
4. Approximately 55 to 65 square feet of ceiling texture in the common bathrooms on each floor in generally good condition.
5. Approximately 250 to 300 square feet of ceiling texture in the east laundry room in generally good condition.
6. Approximately 250 to 300 square feet of ceiling texture in the west laundry room in generally good condition.

Plates 1 & 2: Showing asbestos containing ceiling texture material on the 3rd and 4th floor corridors respectively. (Typical).

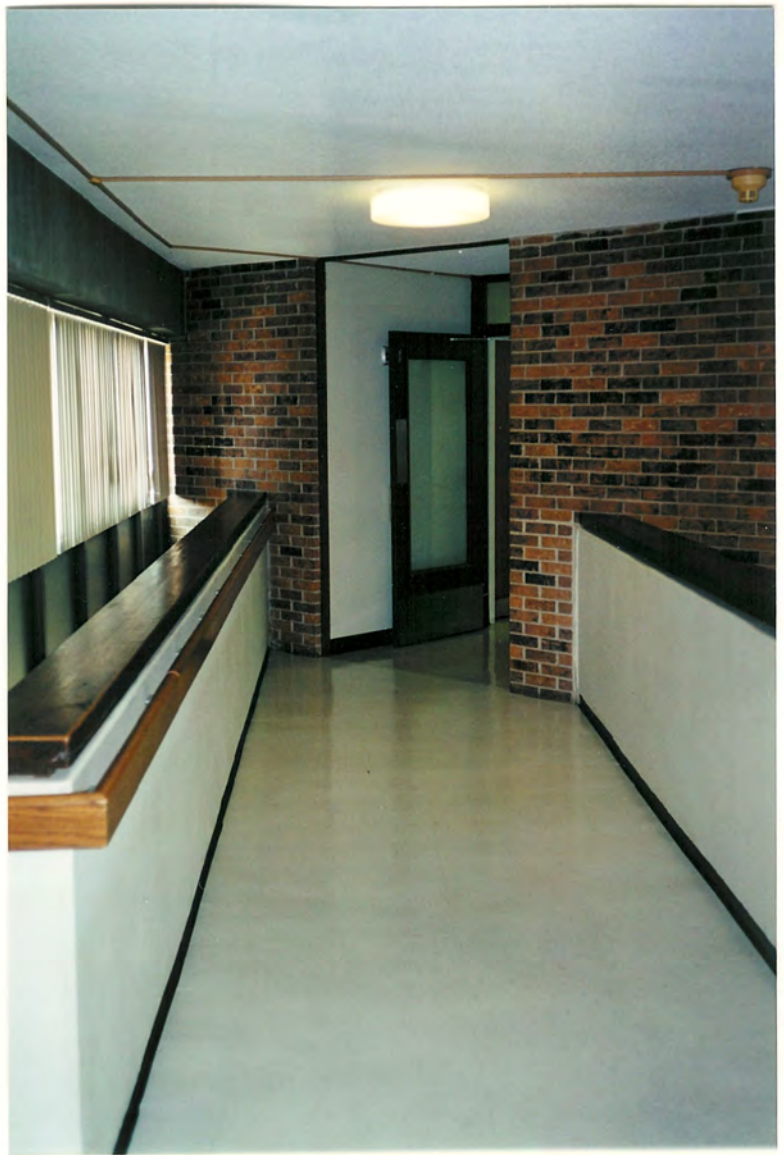
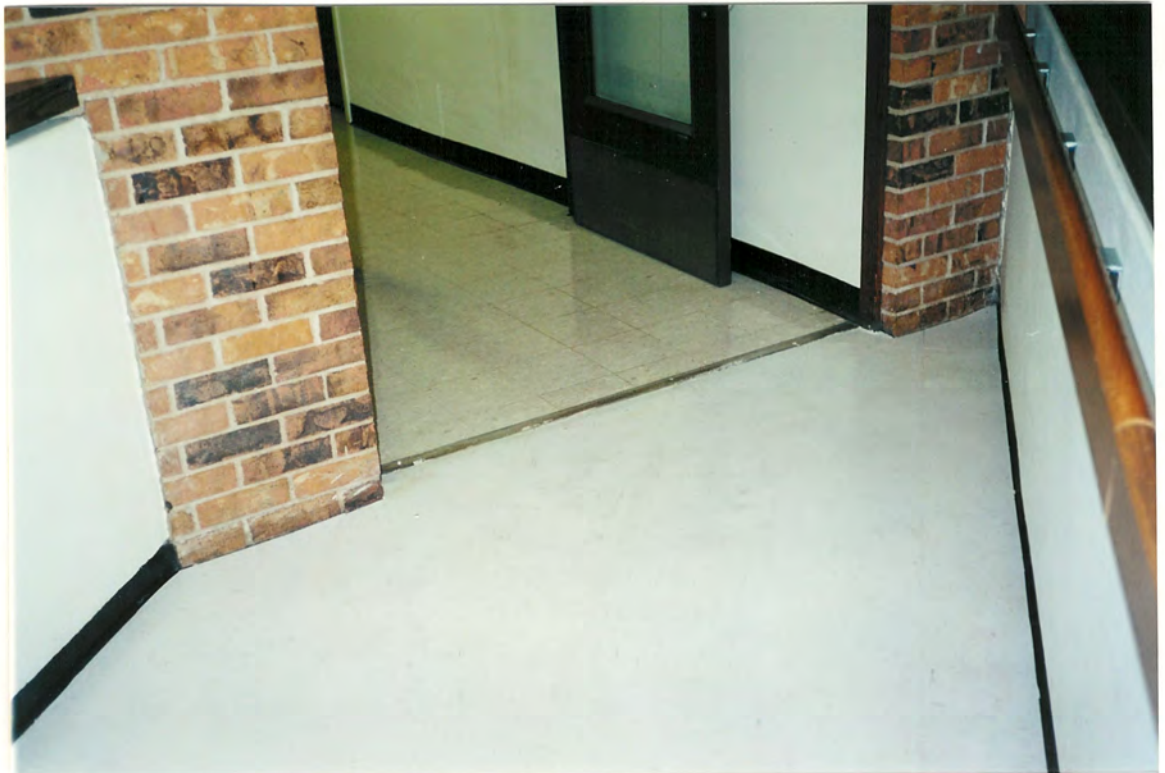
1. Approximately 900 to 950 square feet of black floor tile mastic beneath non-ACM 12”x12” floor tiles in the fifth floor corridor in generally good condition.
2. Approximately 3,000 to 3,500 square feet of black floor tile mastic beneath non-ACM 12”x12” floor tiles in the second floor corridors.

Plates 5 & 6: Showing the extent of the S.K. and N. removal effort of the 9" x 9" and 12" x 12" floor tiles. Black colored asphaltic ACM mastic remains under the new floor covering.
