## Asbestos-Containing Material Survey Report

Site: **Housing Authority of Cook County  
John Mackler Homes and Sunrise Apartments  
12<sup>th</sup> Street and 5<sup>th</sup> Avenue  
Chicago Heights, Illinois 60411**

Survey Dates: **May 1, 2020 thru May 15, 2020**

Project No.: **A110530057**

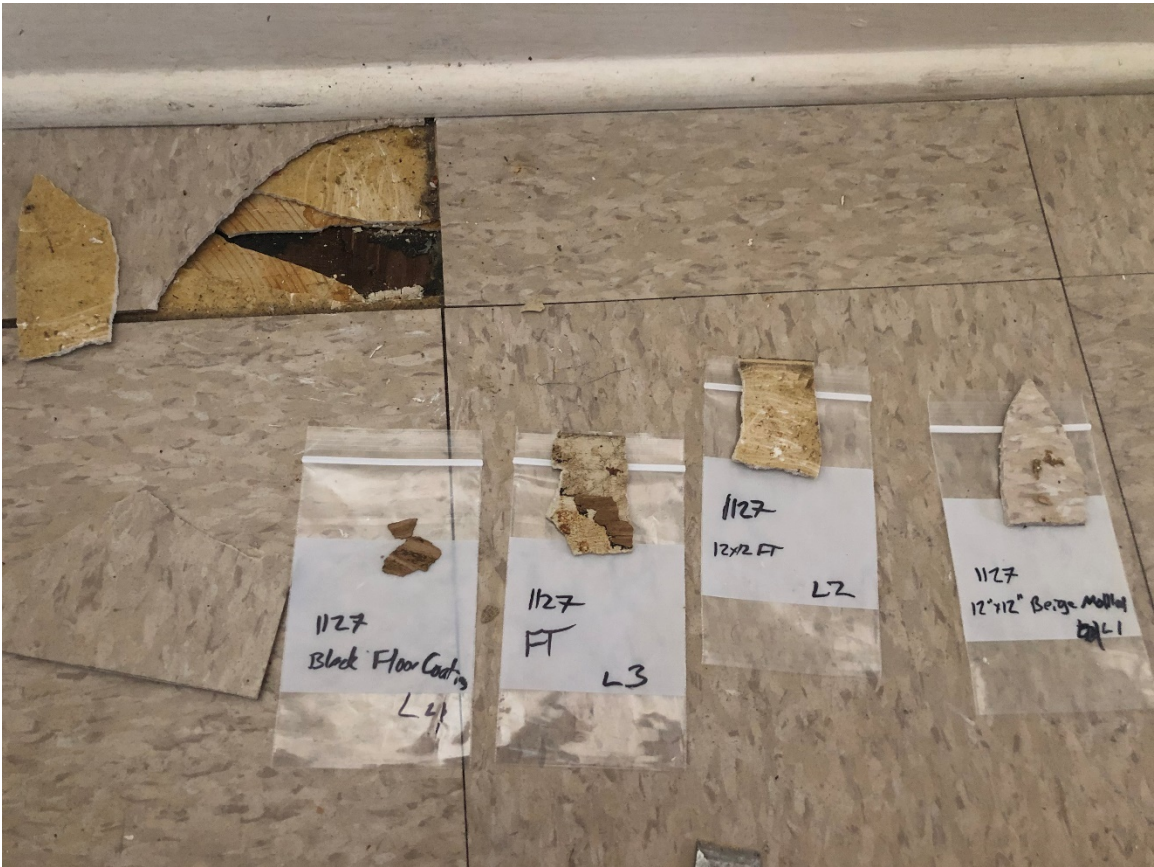
Photo 1: Multiple Layers of Flooring (typ.)

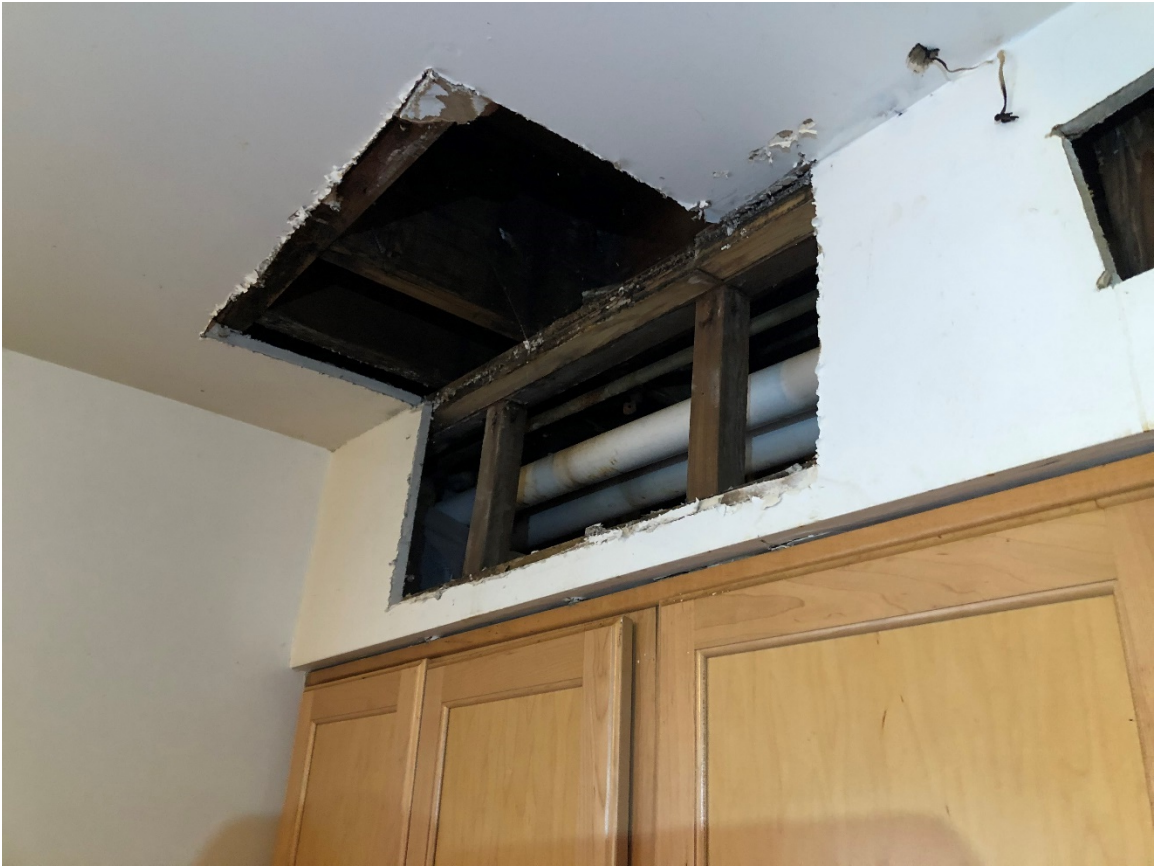
Photo 2: Drywall and Drywall Joint Compound

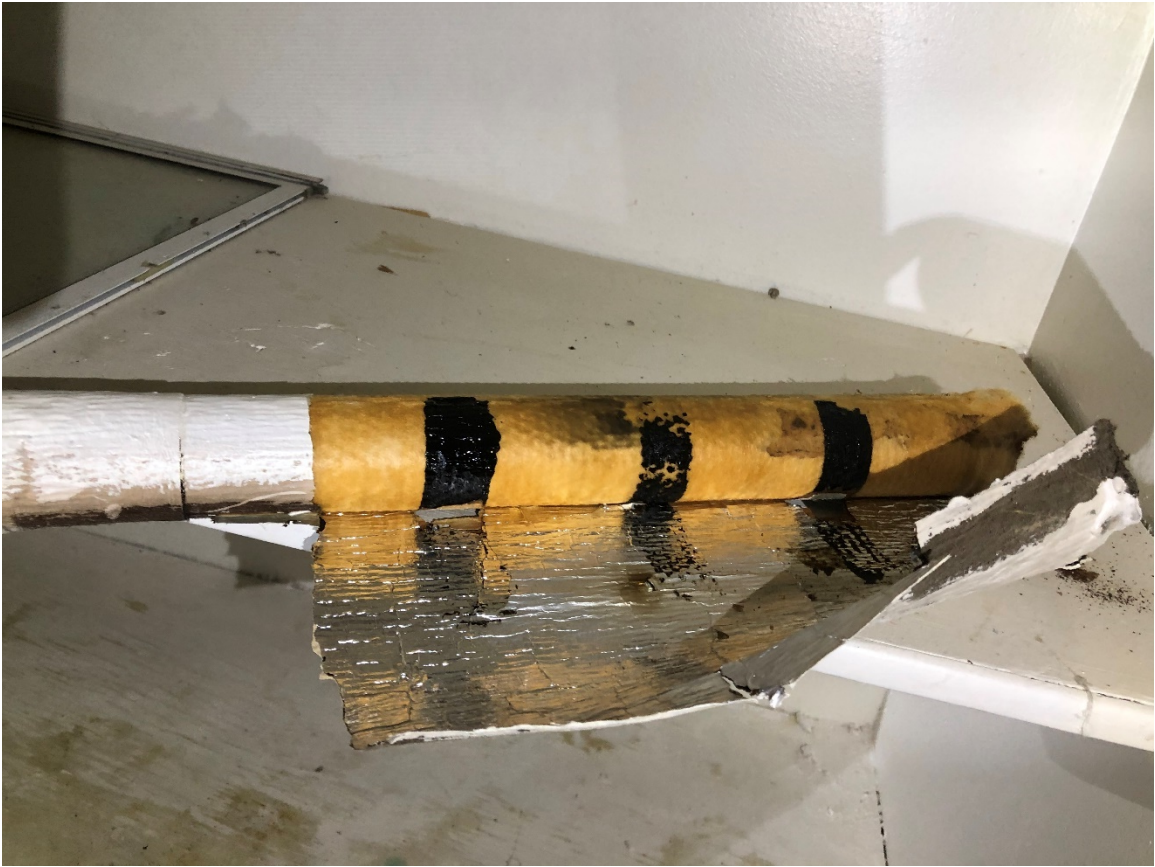
Photo 3: Black Tar on Fiberglass Insulation

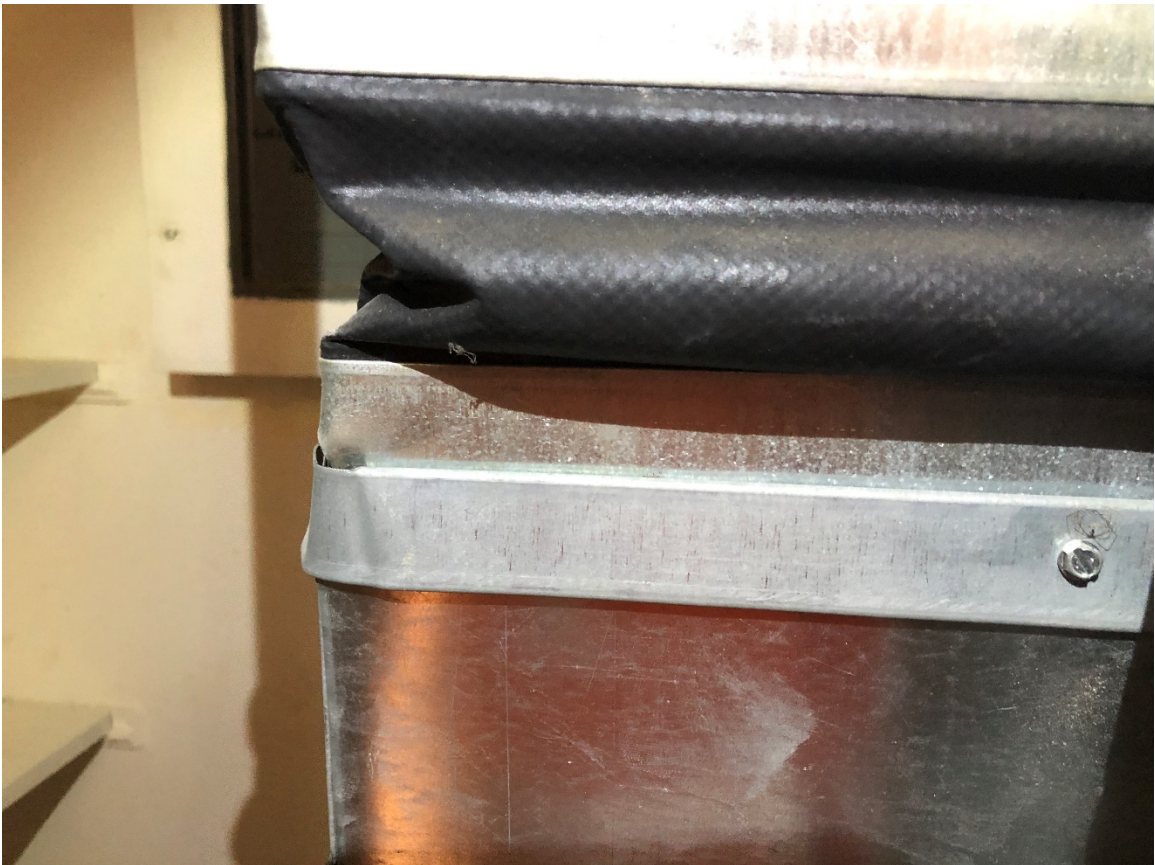
Photo 4: Black Vinyl Vibration Damper

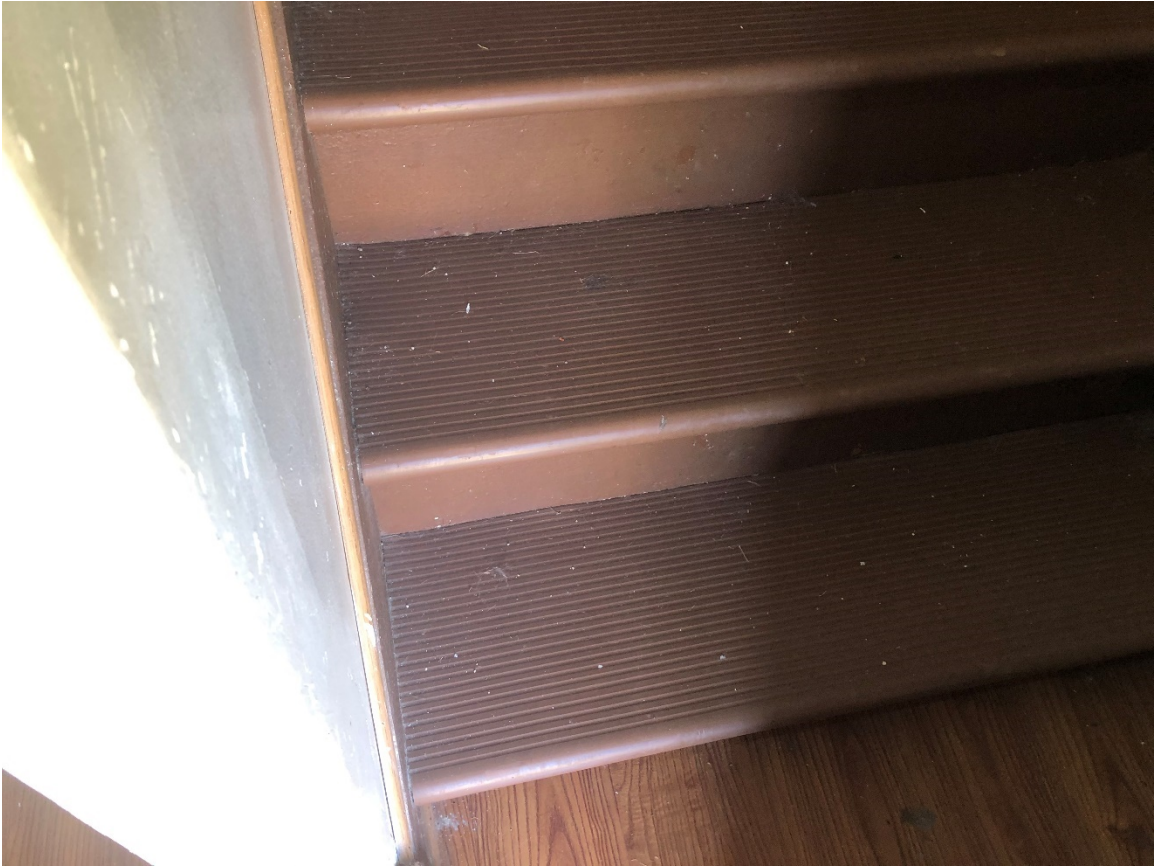
Photo 5: Brown Vinyl Stair Tread

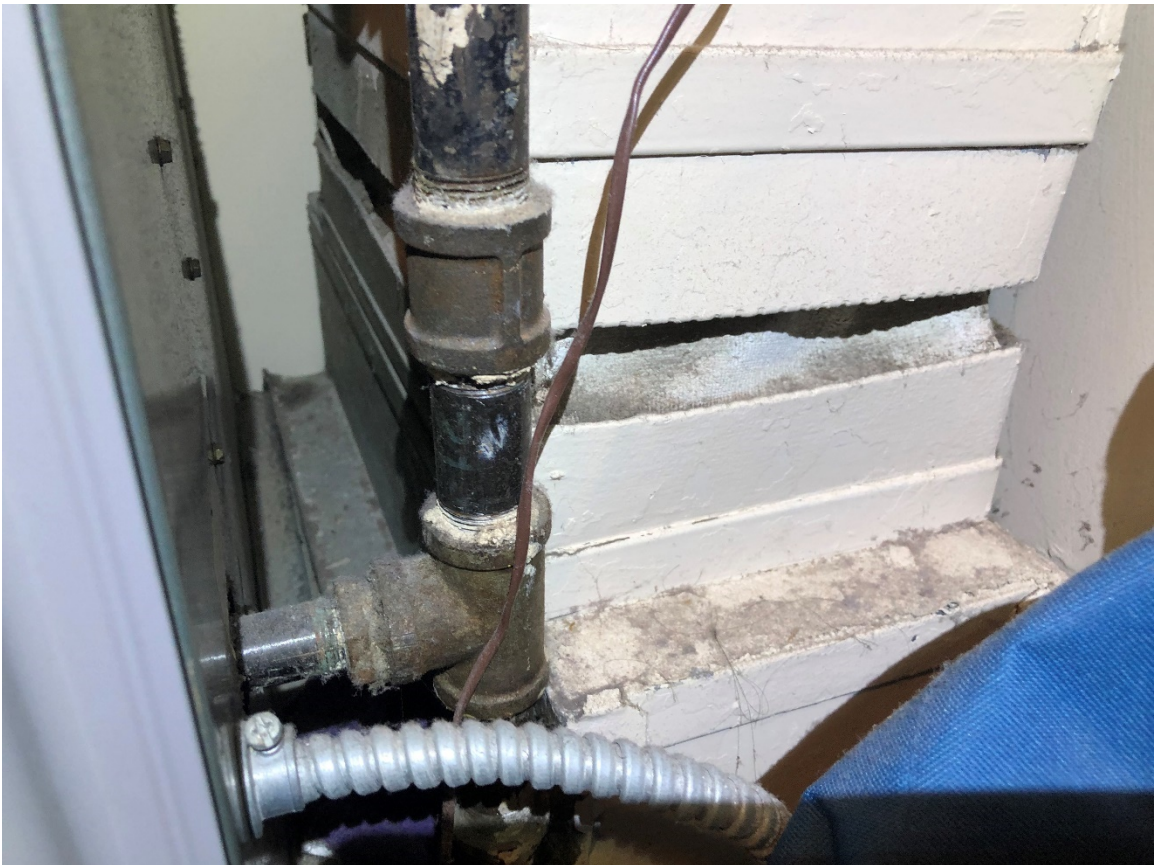
Photo 6: Canvas Vibration Damper

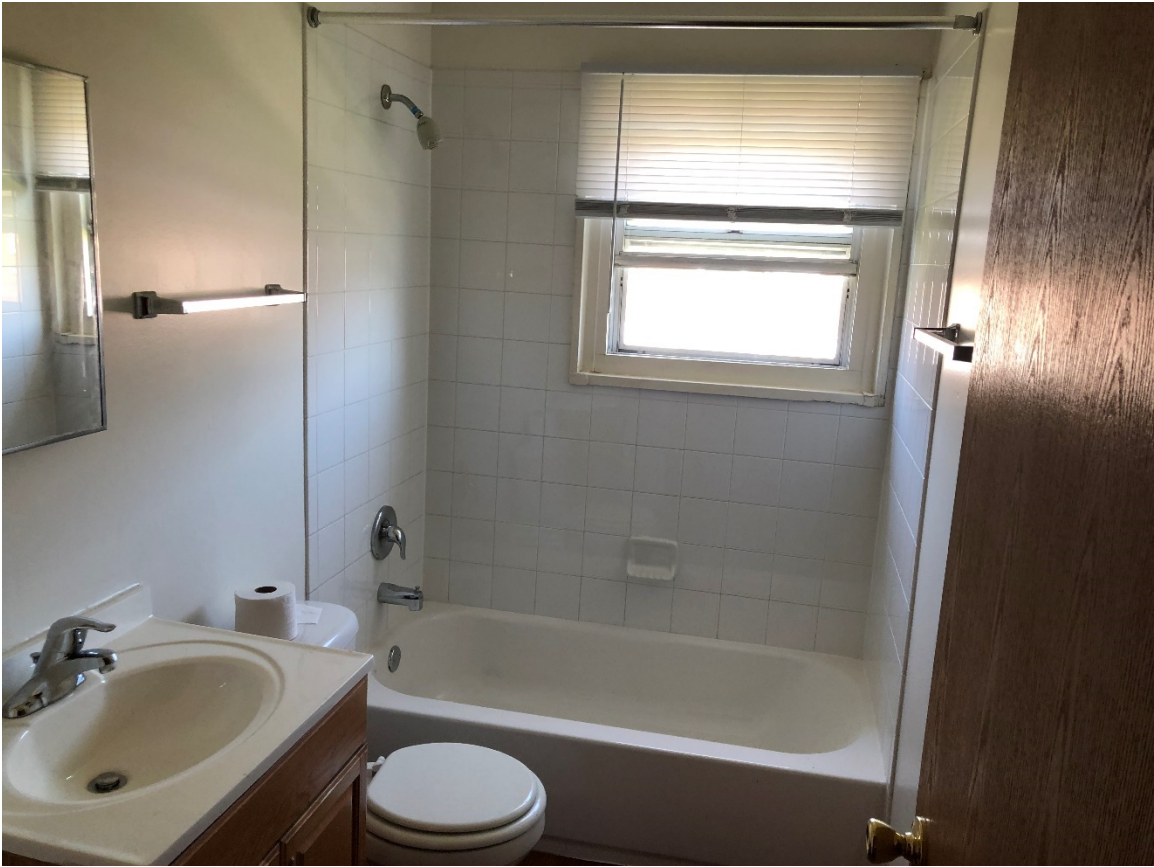
Photo 7: Ceramic Tile Mortar

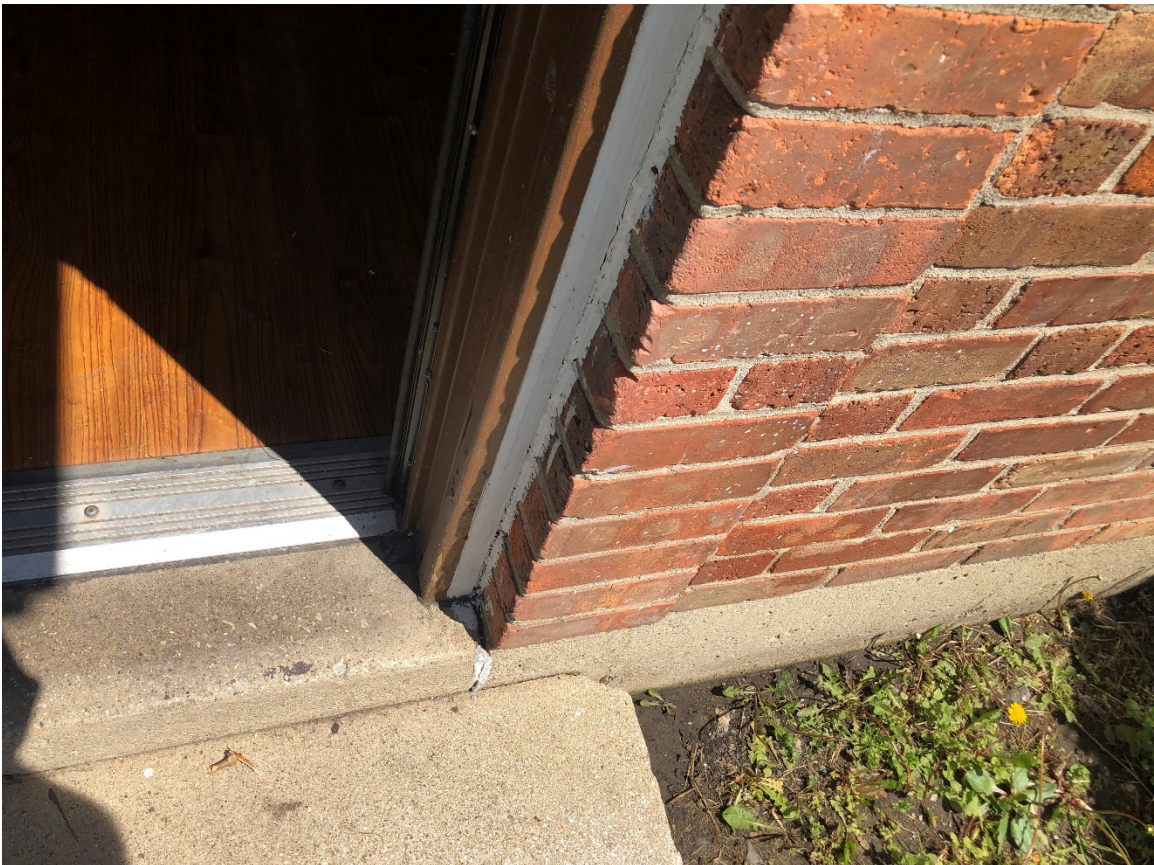
Photo 8: Door Caulk

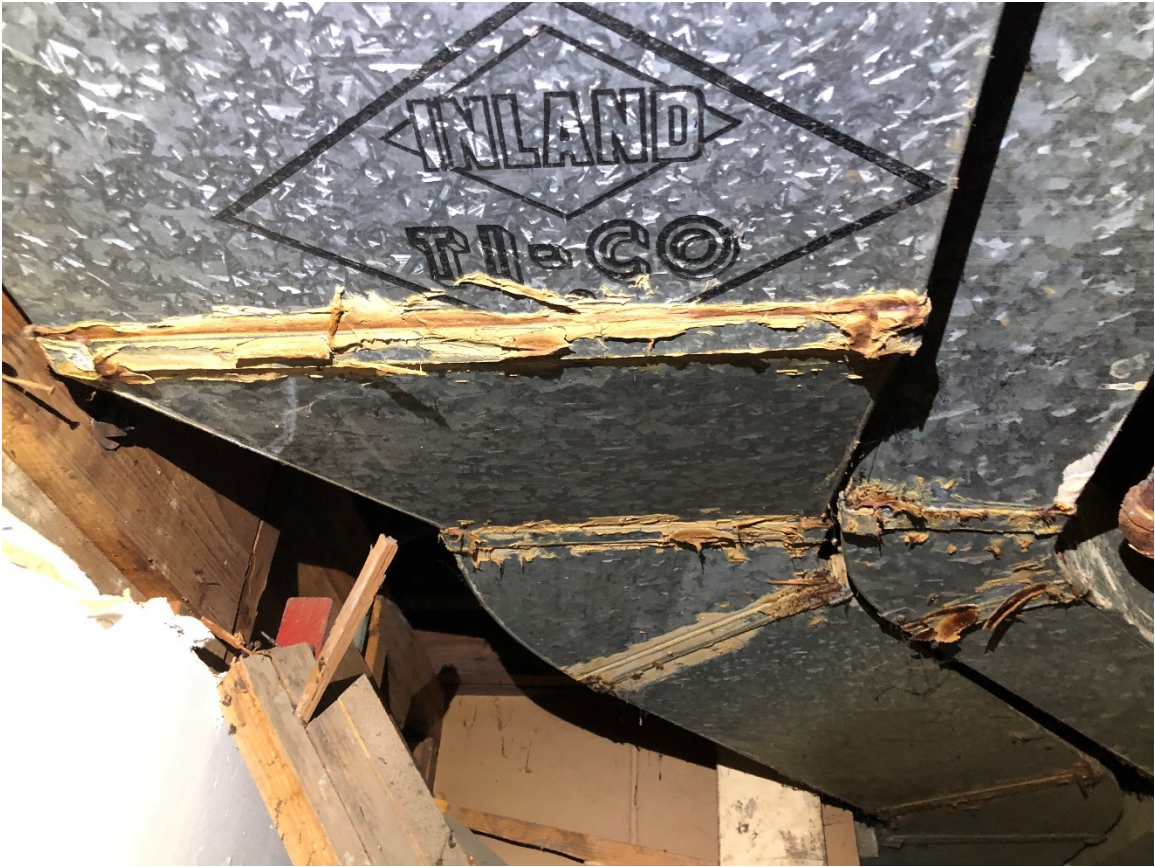
Photo 9: Duct Sealant

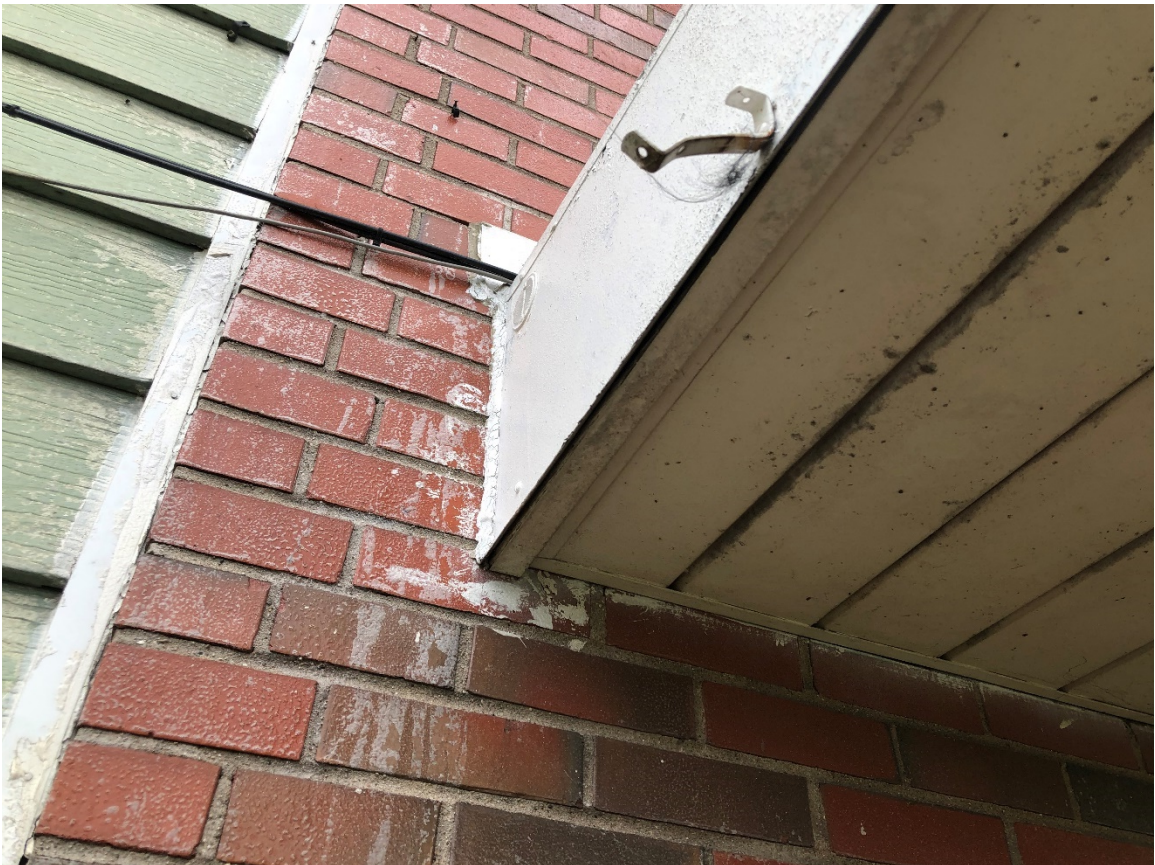
Photo 10: Eave Caulk

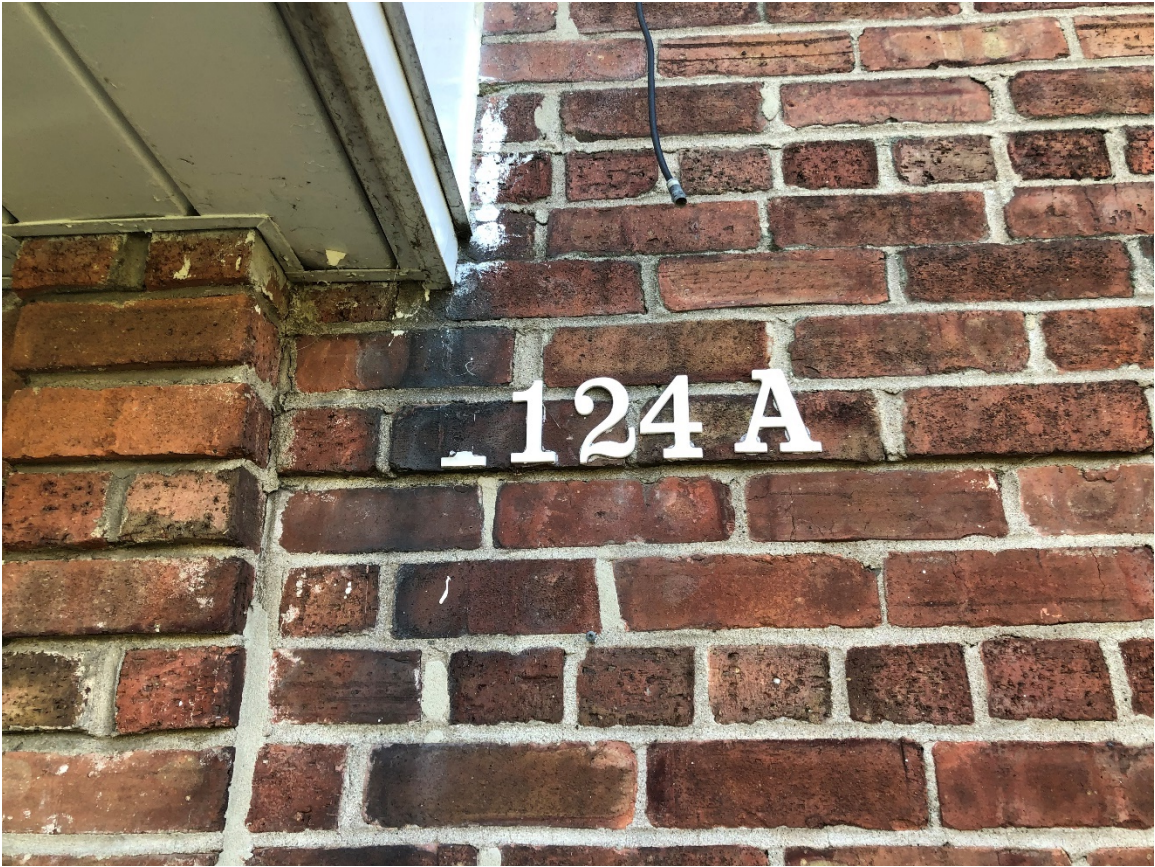
Photo 11: Exterior Brick and Mortar (typ.)

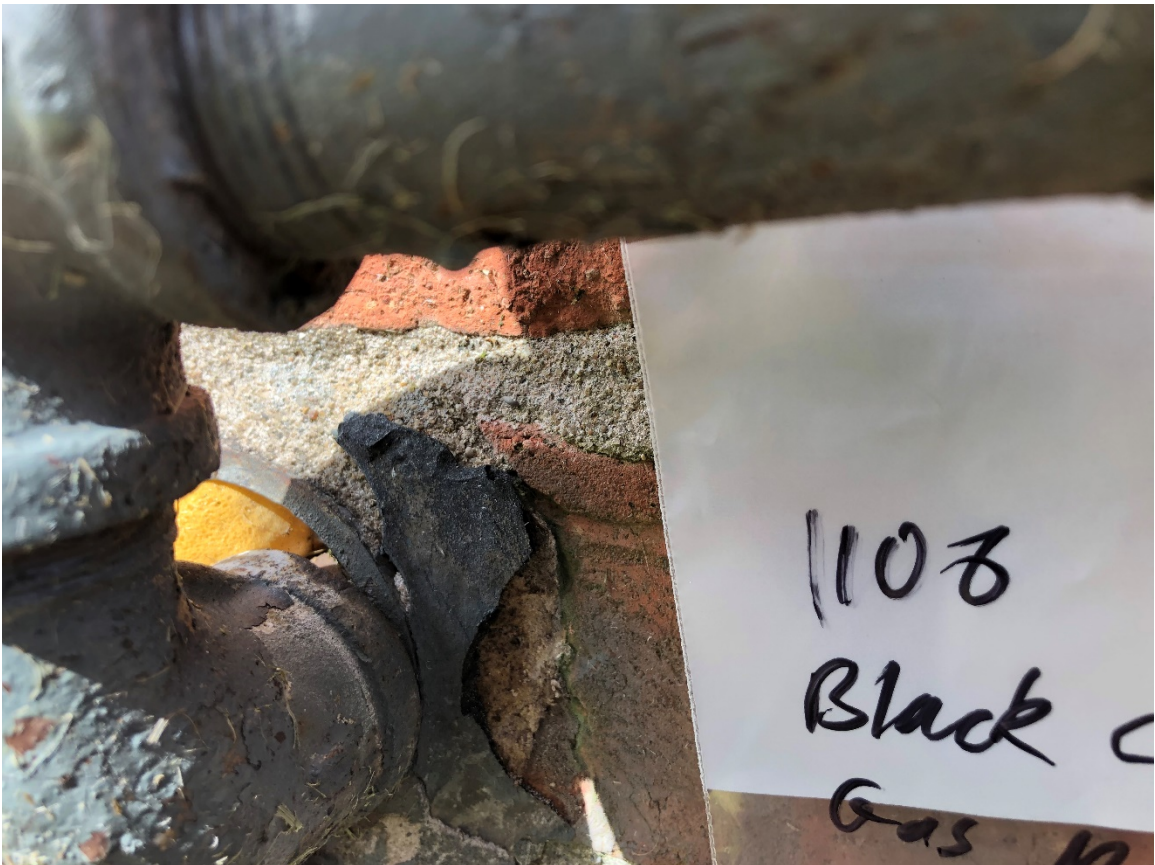
Photo 12: Exterior Black Gas Pipe Caulk

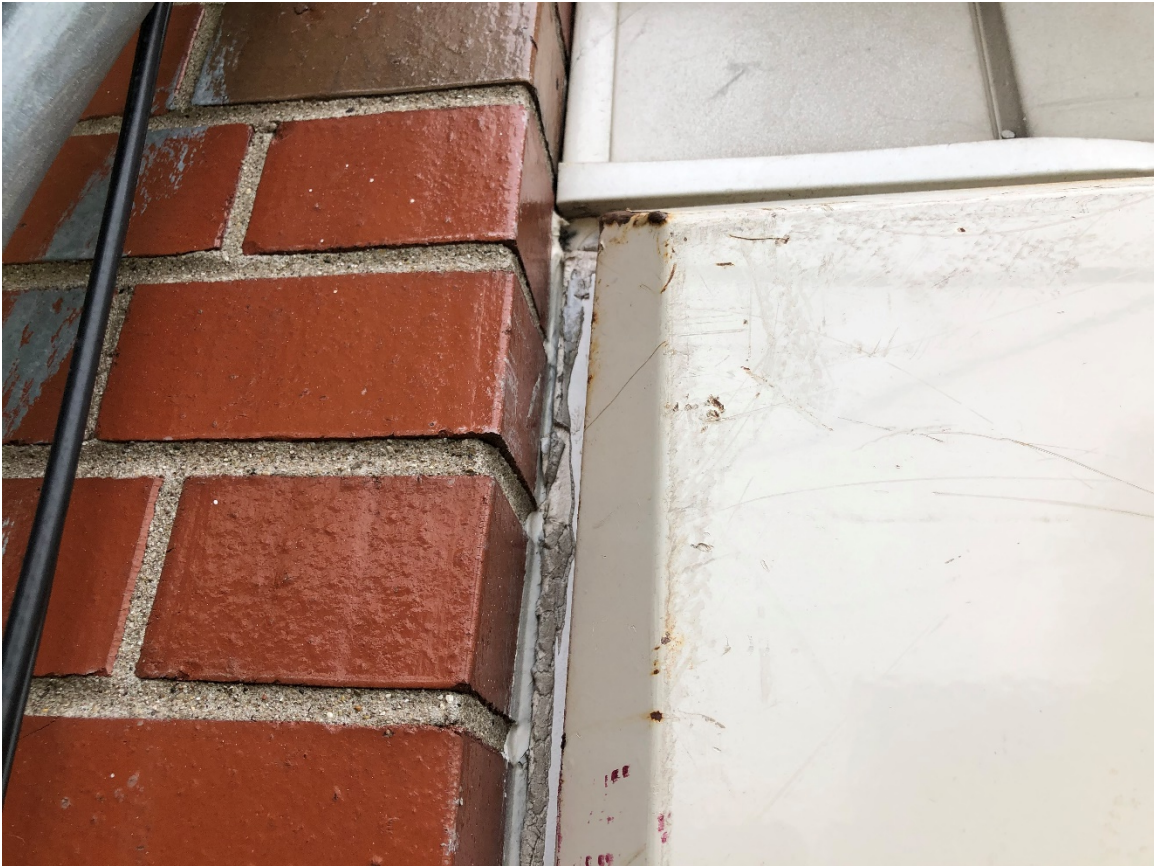
Photo 13: Exterior Siding Caulk

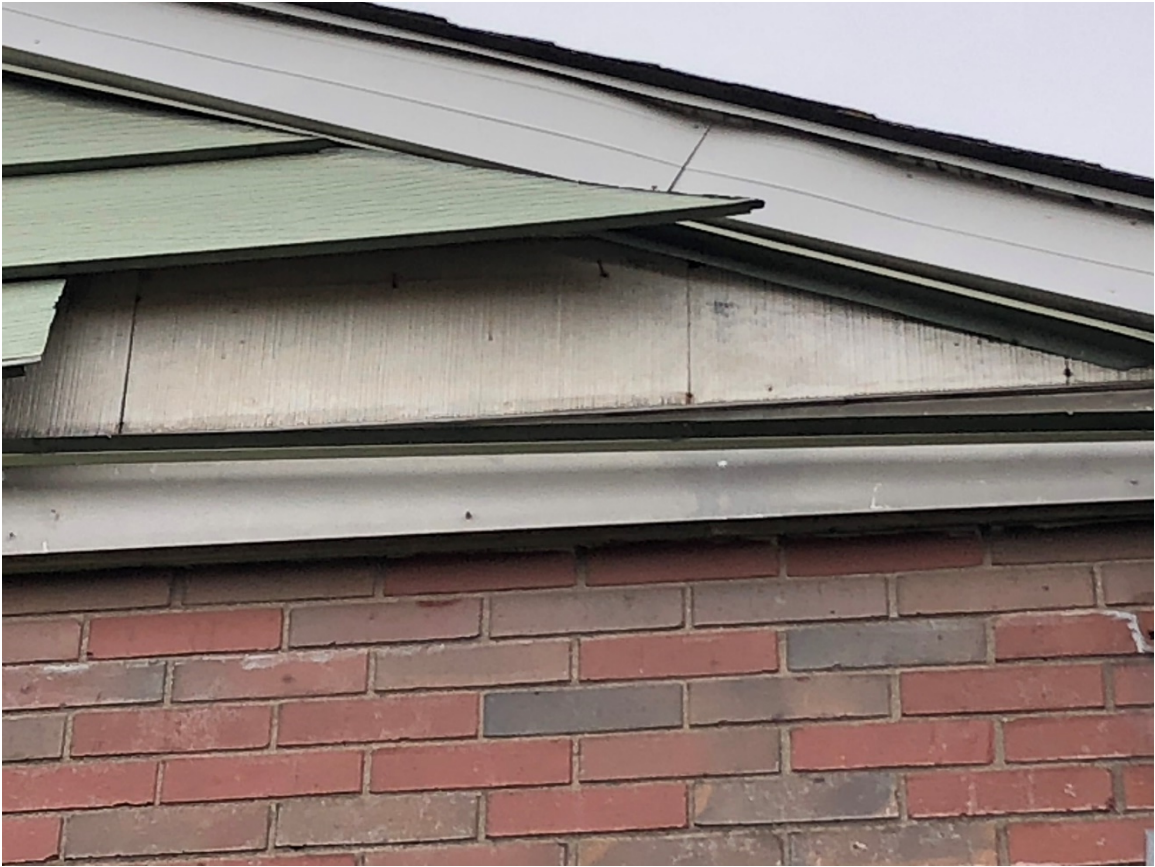
Photo 14: Exterior Transite (behind Vinyl Siding)

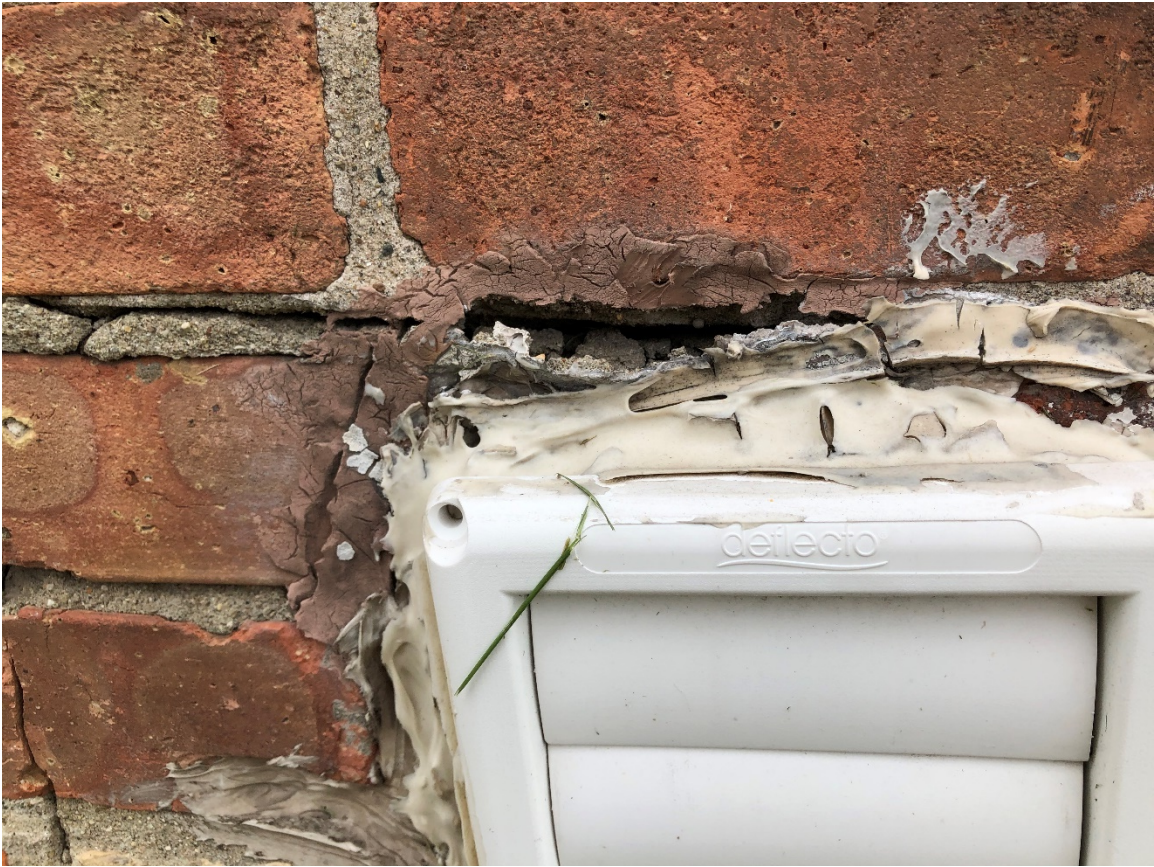
Photo 15: Exterior Vent Caulk

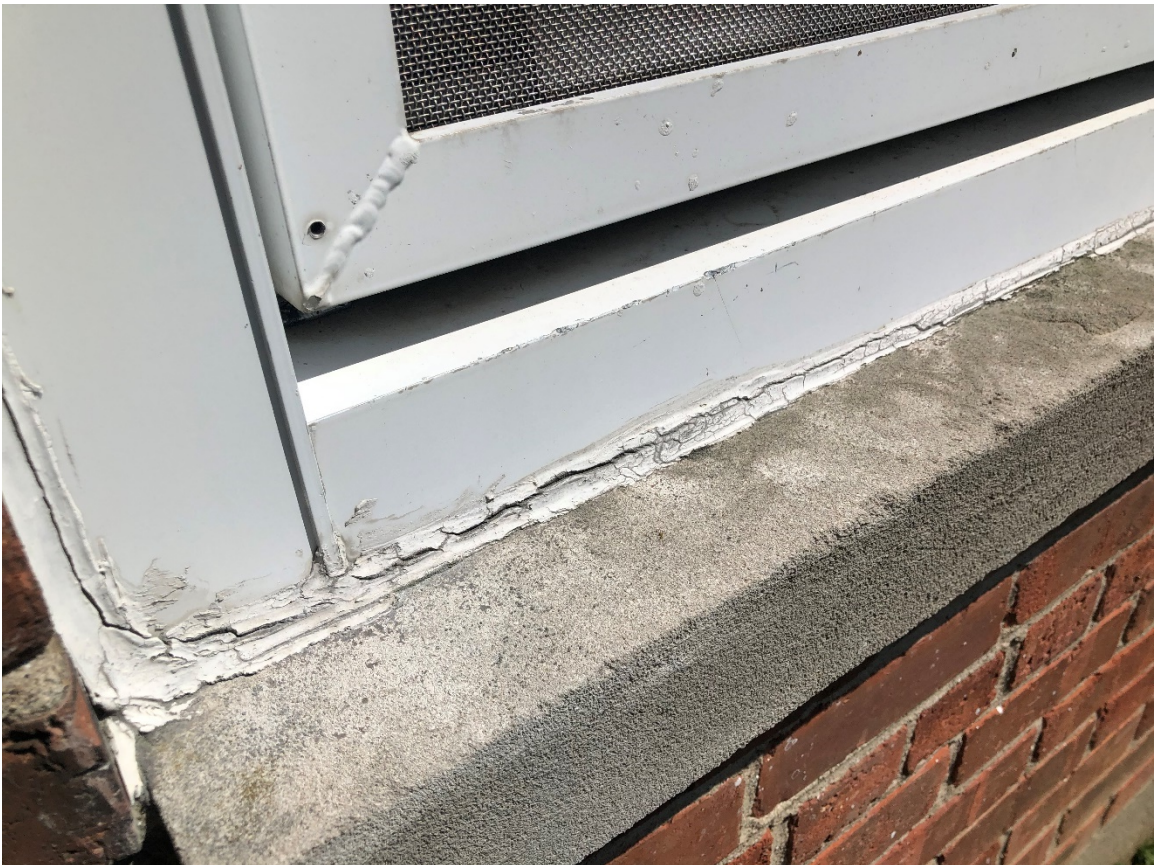
Photo 16: Exterior Window Caulk

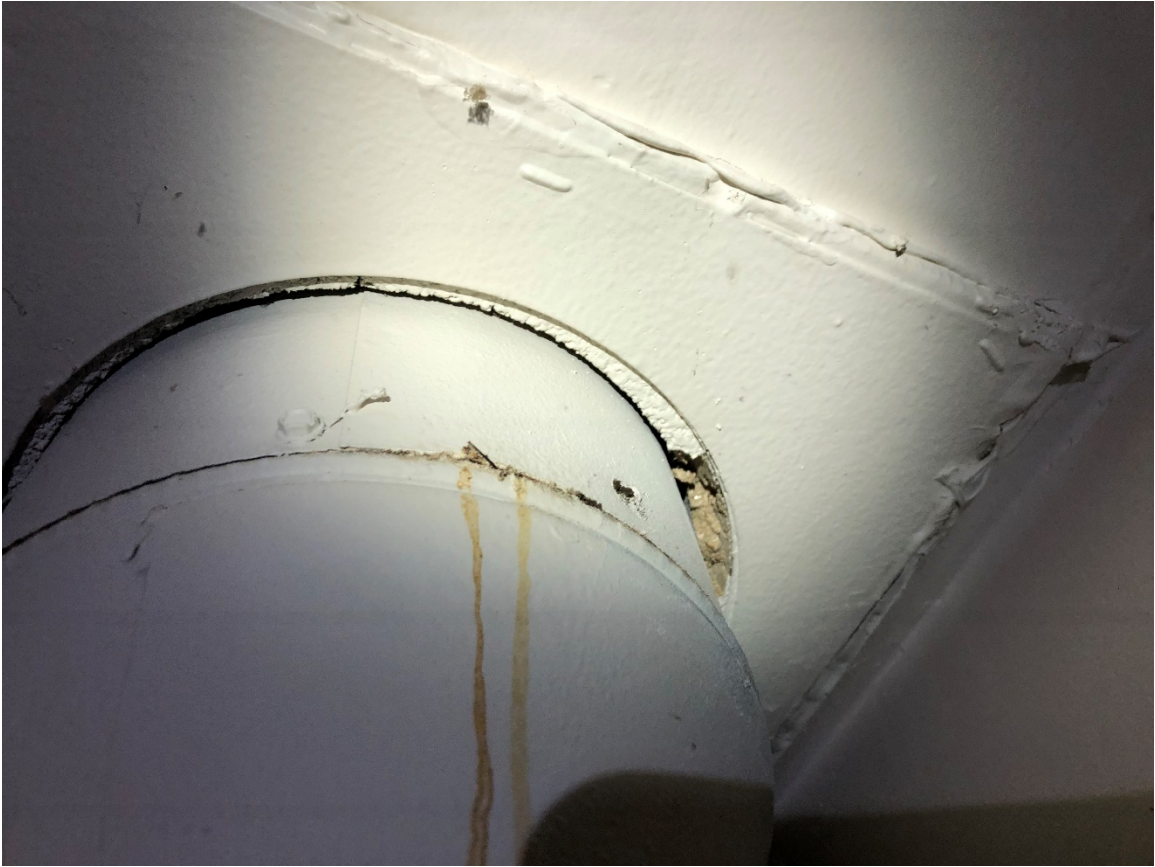
Photo 17: Flue Insulation

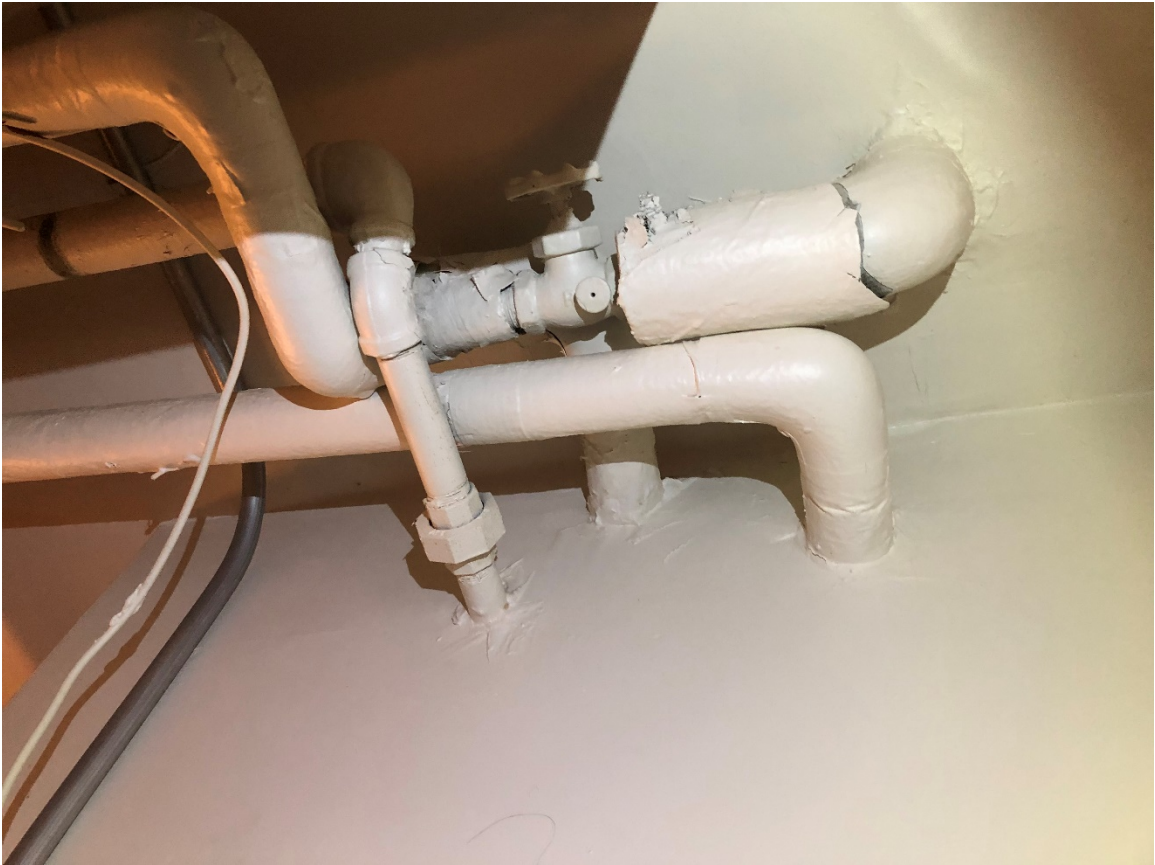
Photo 18: Pipe Fitting Insulation (Hard Elbow)

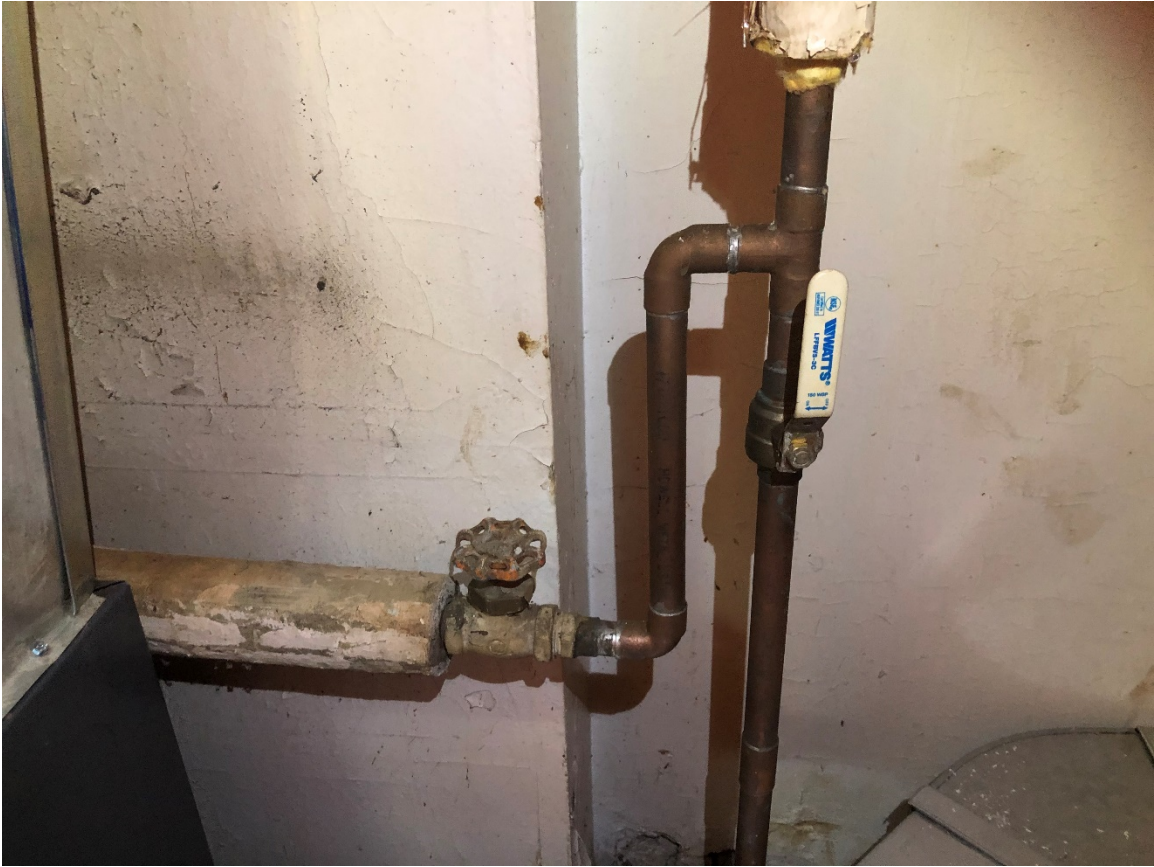
Photo 19: Paperwrap Pipe Insulation

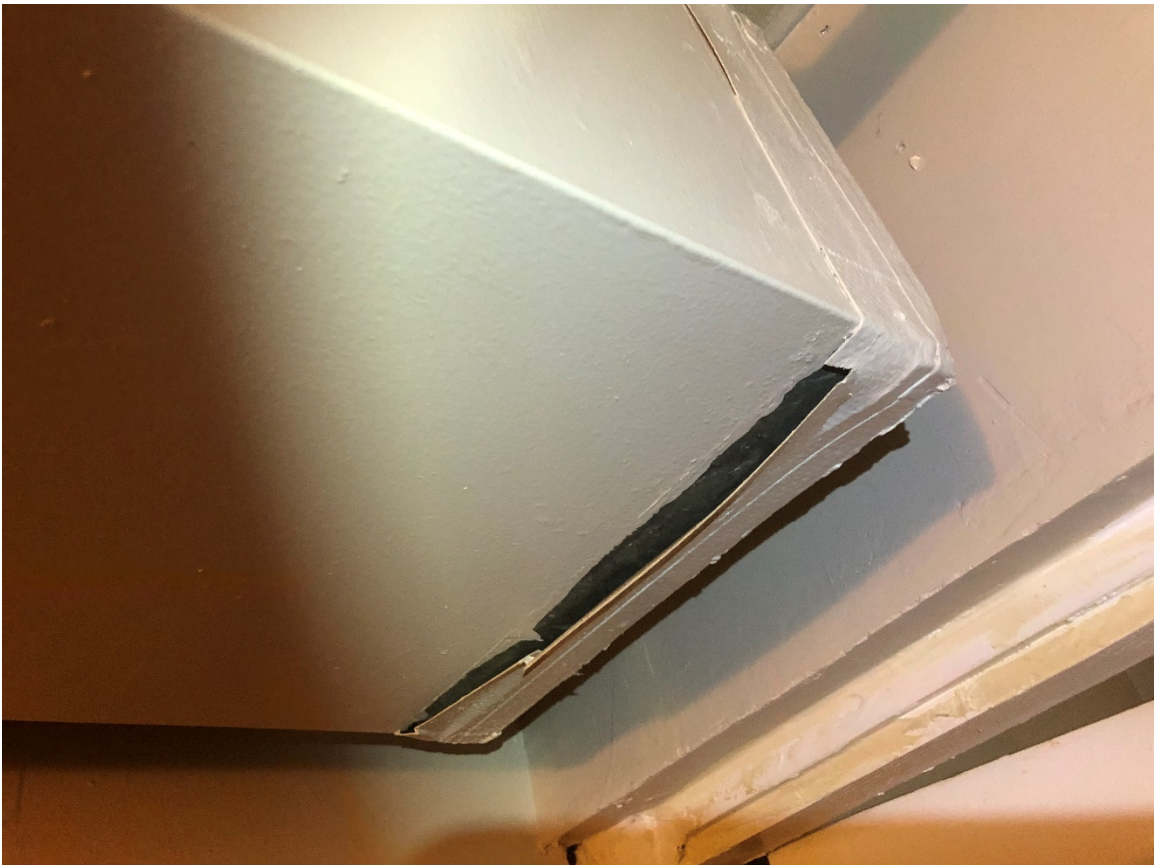
Photo 20: Paper Duct Wrap

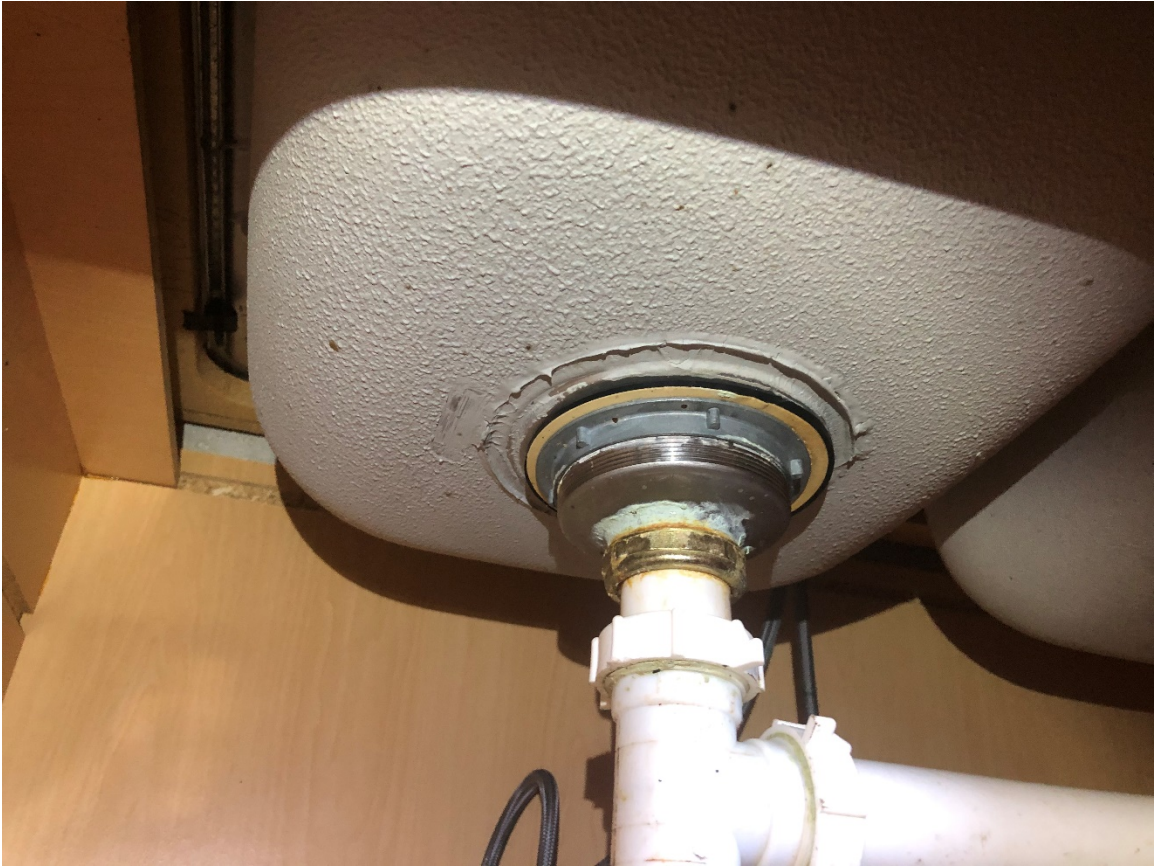
Photo 21: Grey Sink Undercoating

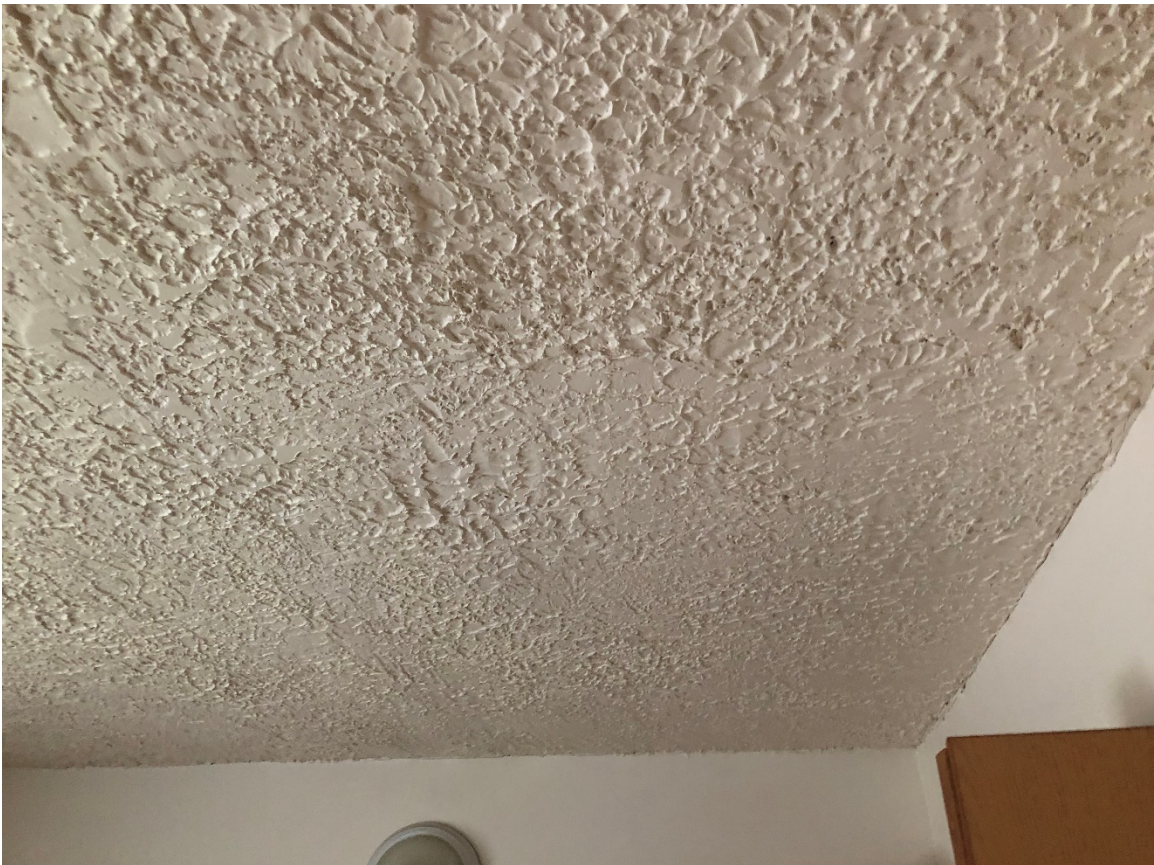
Photo 22: Textured Ceiling

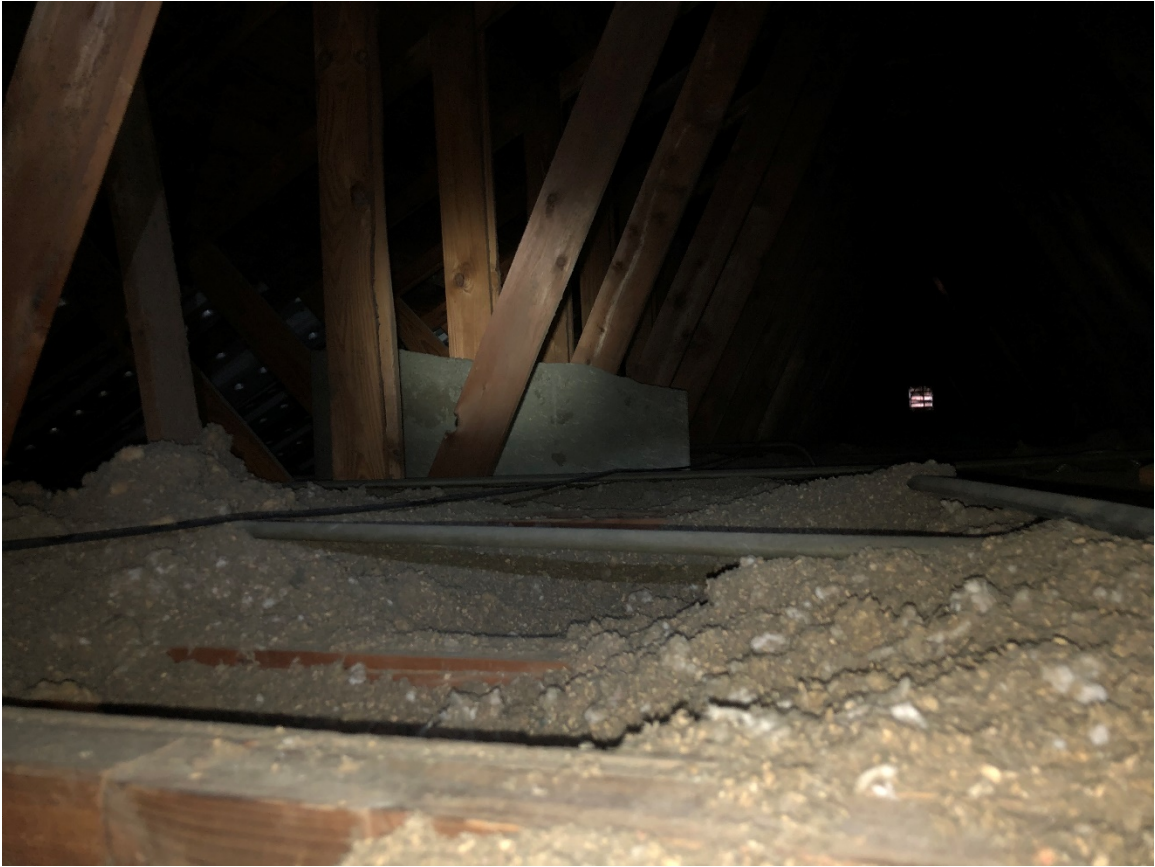
Photo 23: Transite in Attic
