## Asbestos-Containing Material Survey Report

Site: **Housing Authority of Cook County  
John Mackler Homes and Sunrise Apartments  
12<sup>th</sup> Street and 5<sup>th</sup> Avenue  
Chicago Heights, Illinois 60411**

Survey Dates: **May 1, 2020 thru May 15, 2020**

Project No.: **A110530057**

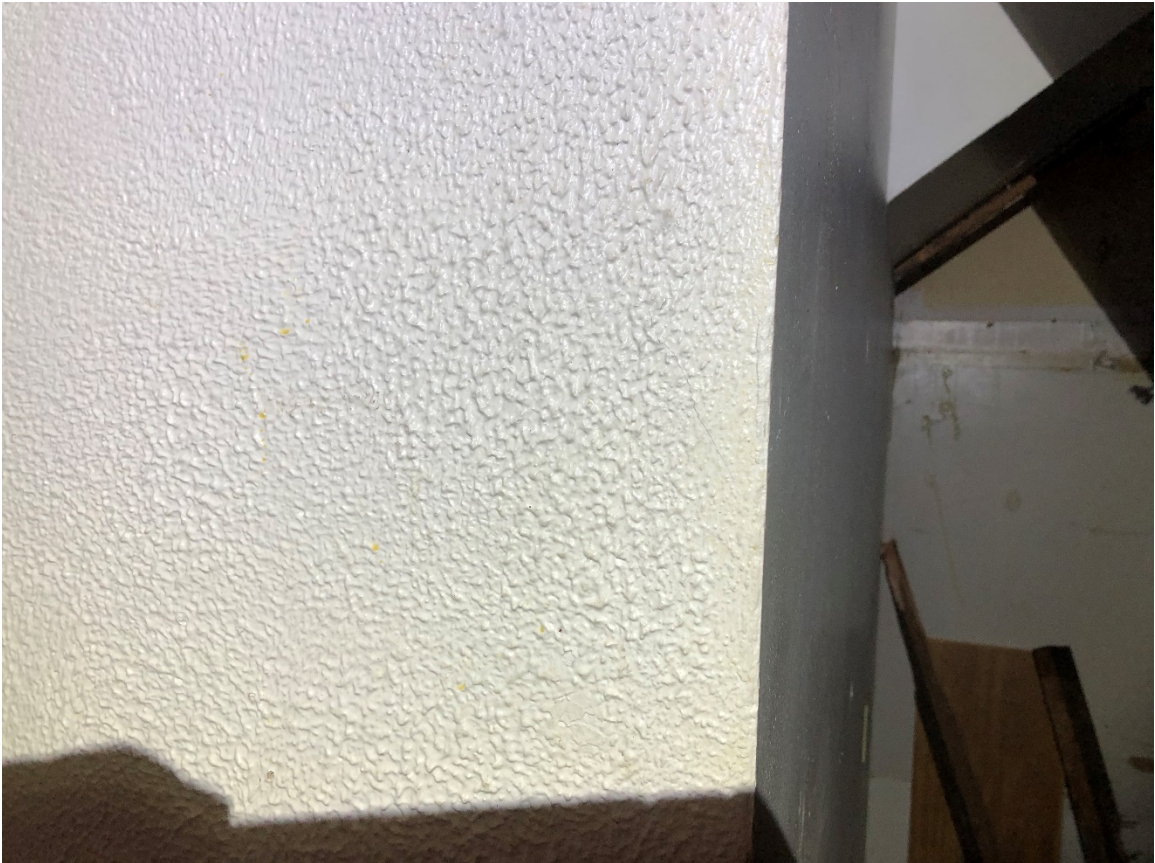
Photo 24: Textured Wall

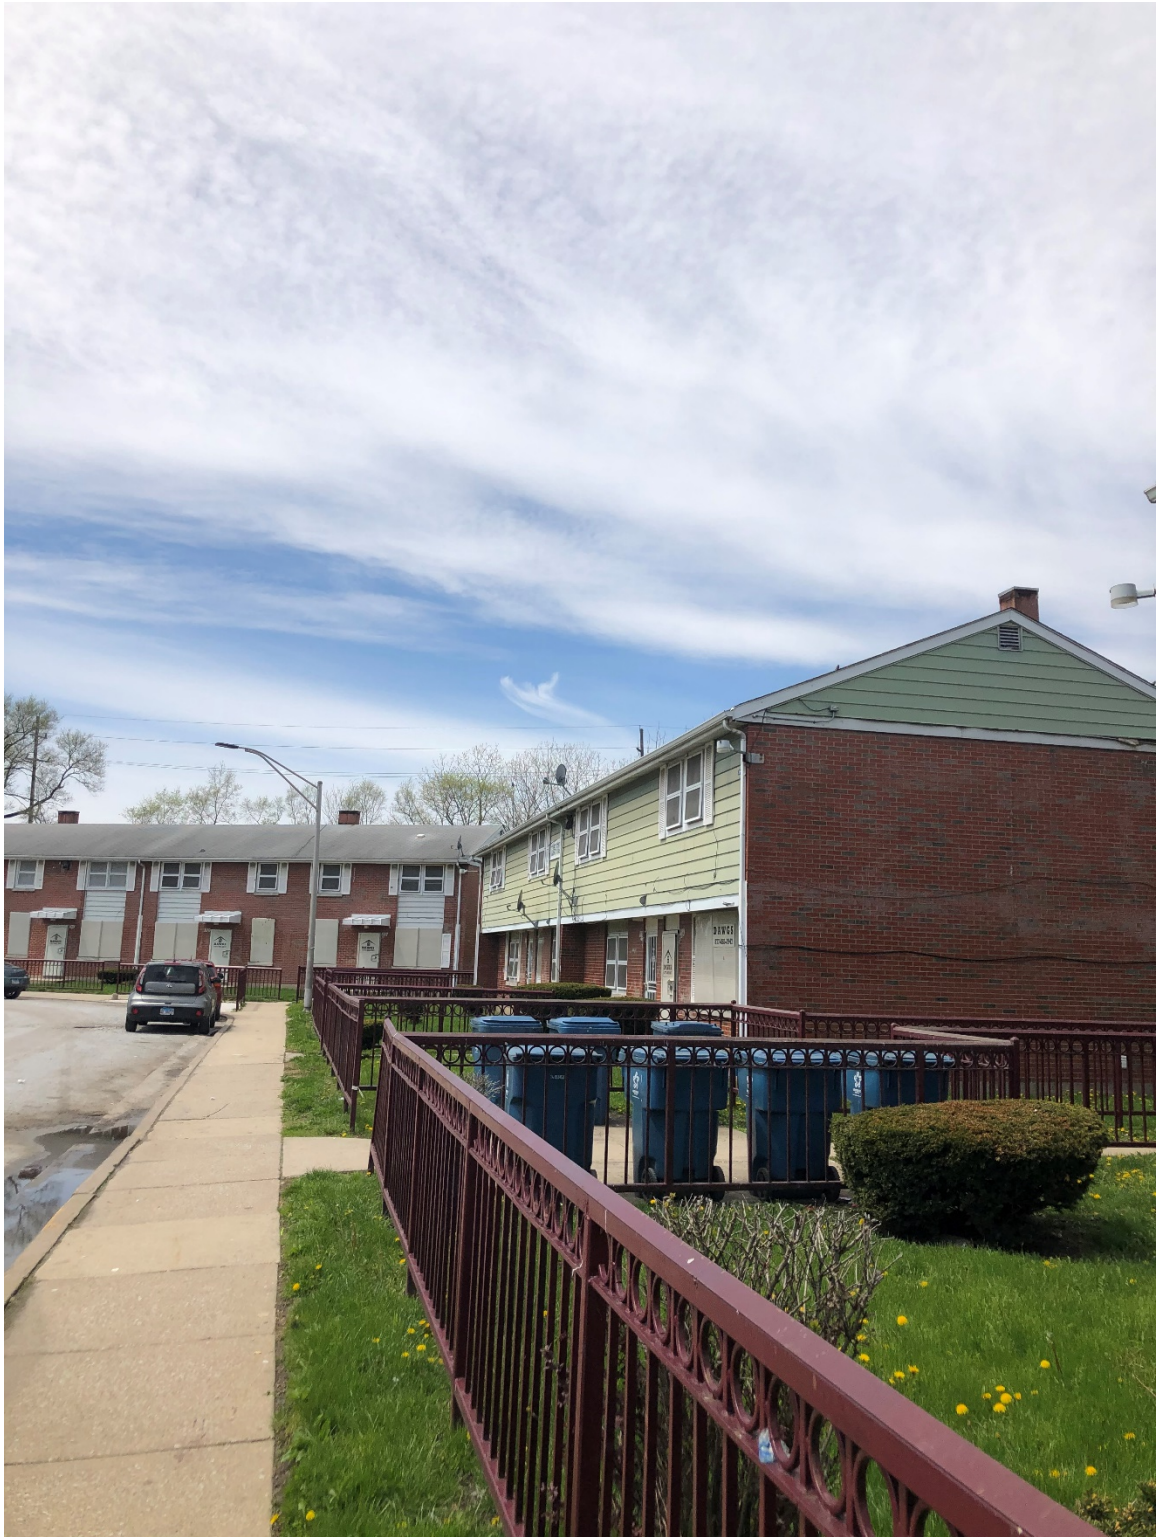
Photo 25: Exterior (typ.)
