**ASBESTOS PRE-DEMOLITION SURVEY**

COMMERCIAL STRUCTURE

7650 WEST 8<sup>TH</sup> AVENUE  
HIALEAH, FLORIDA 33014

**PROJECT NO. 2020-1118**

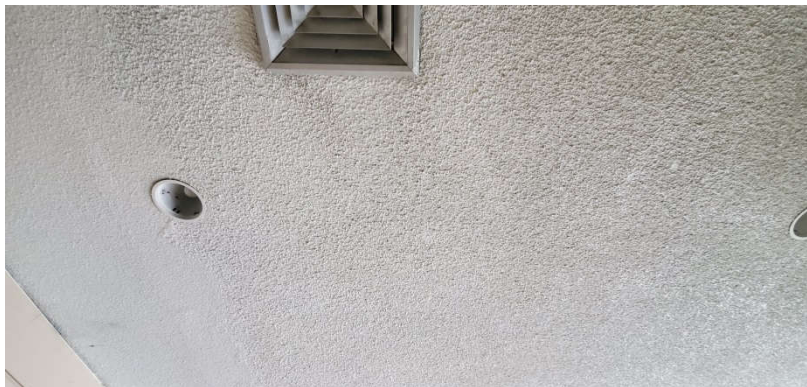
The white popcorn ceiling finish was identified as RACM. This material must be removed prior to renovation activities that will crush, abrade, or pulverize its matrix. Removal and disposal of this material must be performed by a Florida-licensed Asbestos Contractor.

**Photo 2: View of typical RACM popcorn ceiling finish.**

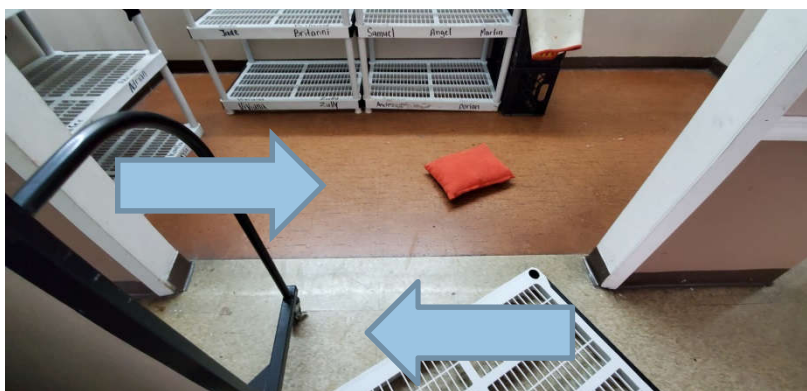
The red vinyl floor tile and black floor mastic was identified as Category I Nonfriable ACM. These materials may remain on the structure during wet demolition provided it remains Nonfriable. However, it must be removed prior to any activities that would release asbestos fibers. Specifically, any demolition activity that will crush, abrade, or dissolve the matrix of this material must be performed by a Florida-licensed Asbestos Contractor. If these materials can remain intact during wet demolition, then removal is not required, but the contractor must still follow NESHAP guidelines and OSHA training and protection requirements.

**Phot 3: Typical view of the red vinyl floor tile (VFT) with black mastic. (Beige floor tile with glue over red VFT with black mastic in the class room).**

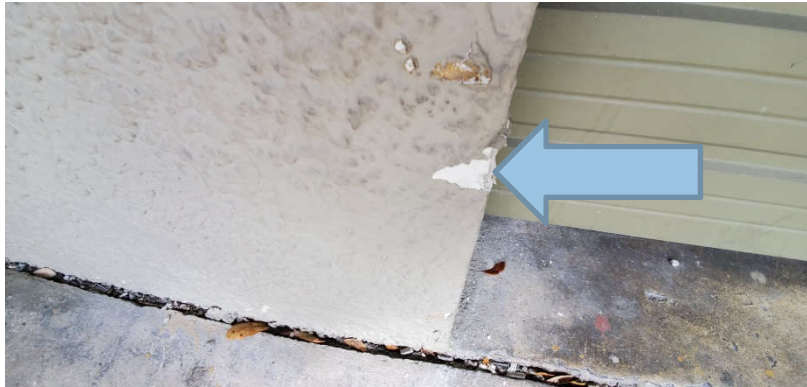
The white exterior stucco walls of the structure were identified as Category II Nonfriable ACM. This material is likely to become friable during demolition and is considered to be regulated ACM (RACM). It must be removed prior to demolition of the structure by a Florida-licensed Asbestos Contractor.

**Photo 4: Typical ACM stucco sampled during this inspection.**

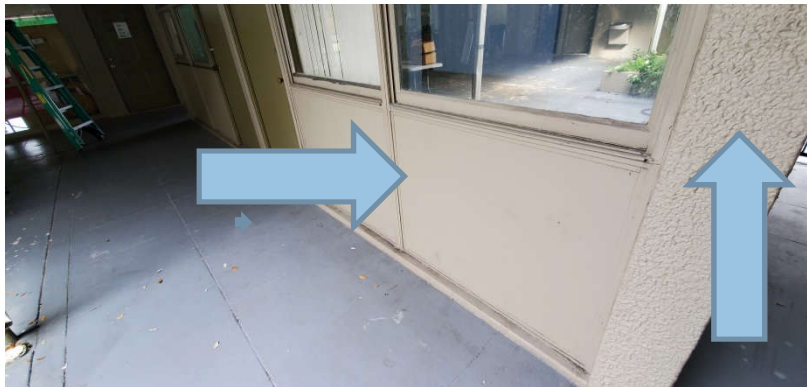
**Photo 5: ACM Transite panels and exterior stucco identified during this inspection.**

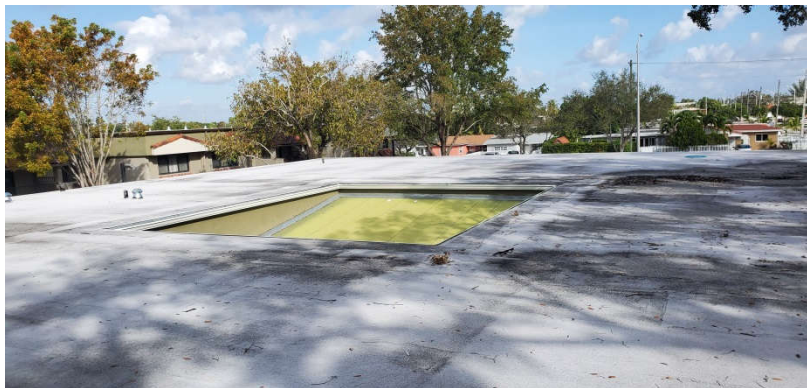
**Photo 6: No asbestos identified in the samples collected of the roofing materials during this inspection.**
