December 28, 2018

Project No. 1765901

**NESHAP Asbestos Survey Report  
Port Lawrence Homes  
834 14<sup>th</sup> Street  
Toledo, Ohio**

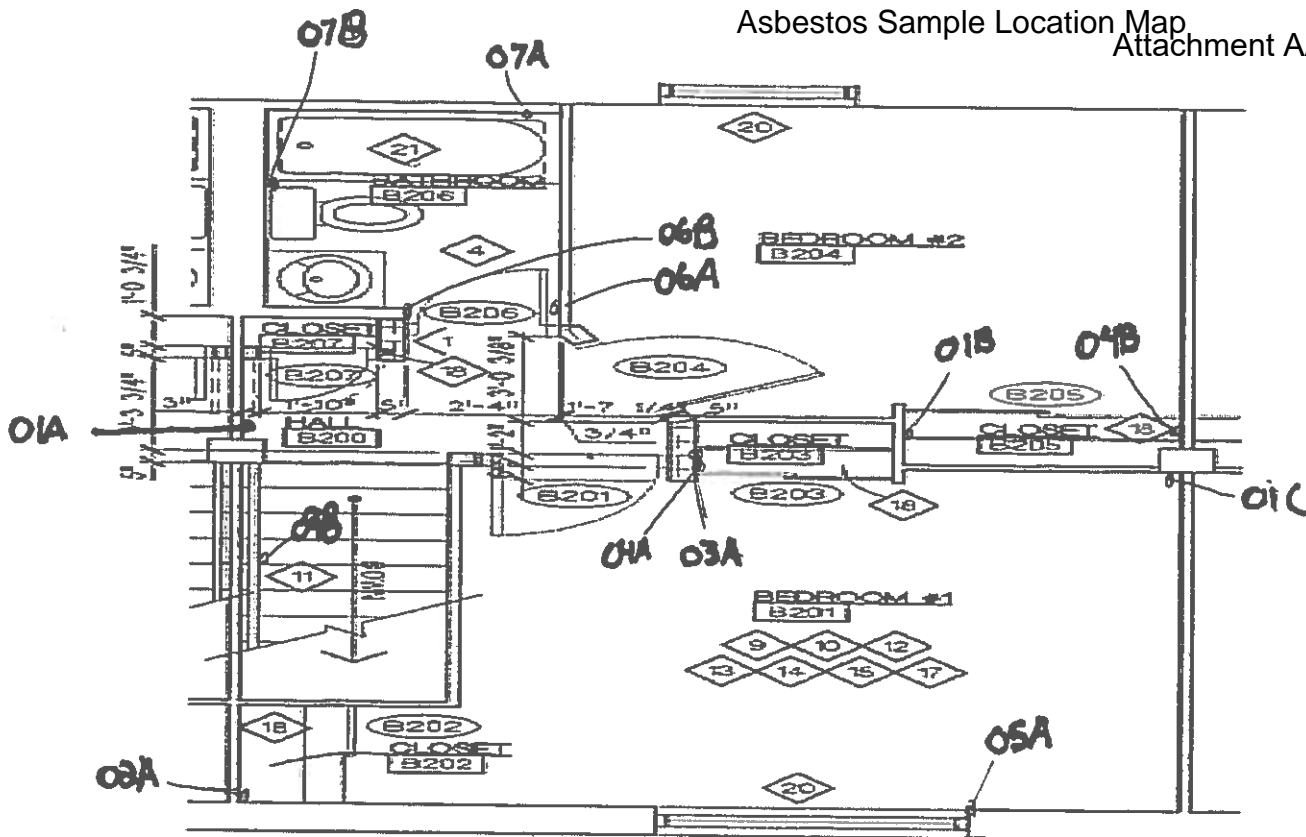
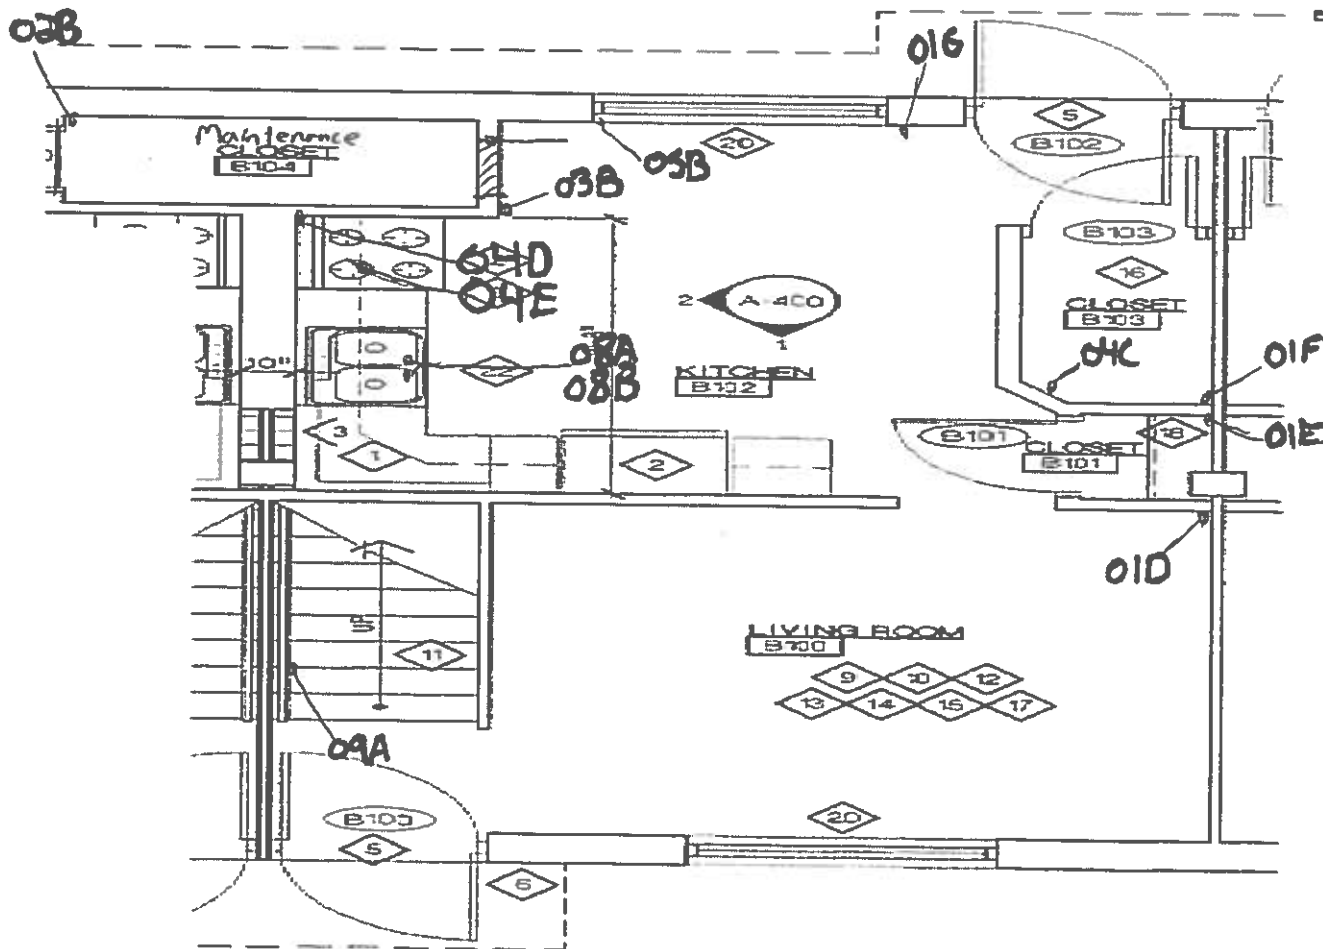
**ATTACHMENT D**  
**SAMPLE LOCATION MAP**

Refer to the NESHAP Asbestos Survey Summary Table in Attachment B for a listing of the materials identified and the analytical results. The laboratory analytical report is located in Attachment C. A map identifying sample locations is included in Attachment D.
