**ASBESTOS INSPECTION SURVEY
OAK GROVE ESTATES
342 OAK VIEW COURT
TOLEDO, OHIO**

**September 22, 2015
Project No. 86234.01**

**Asbestos Inspection Survey
Oak Grove Estates
342 Oak View Court
Toledo, Ohio**

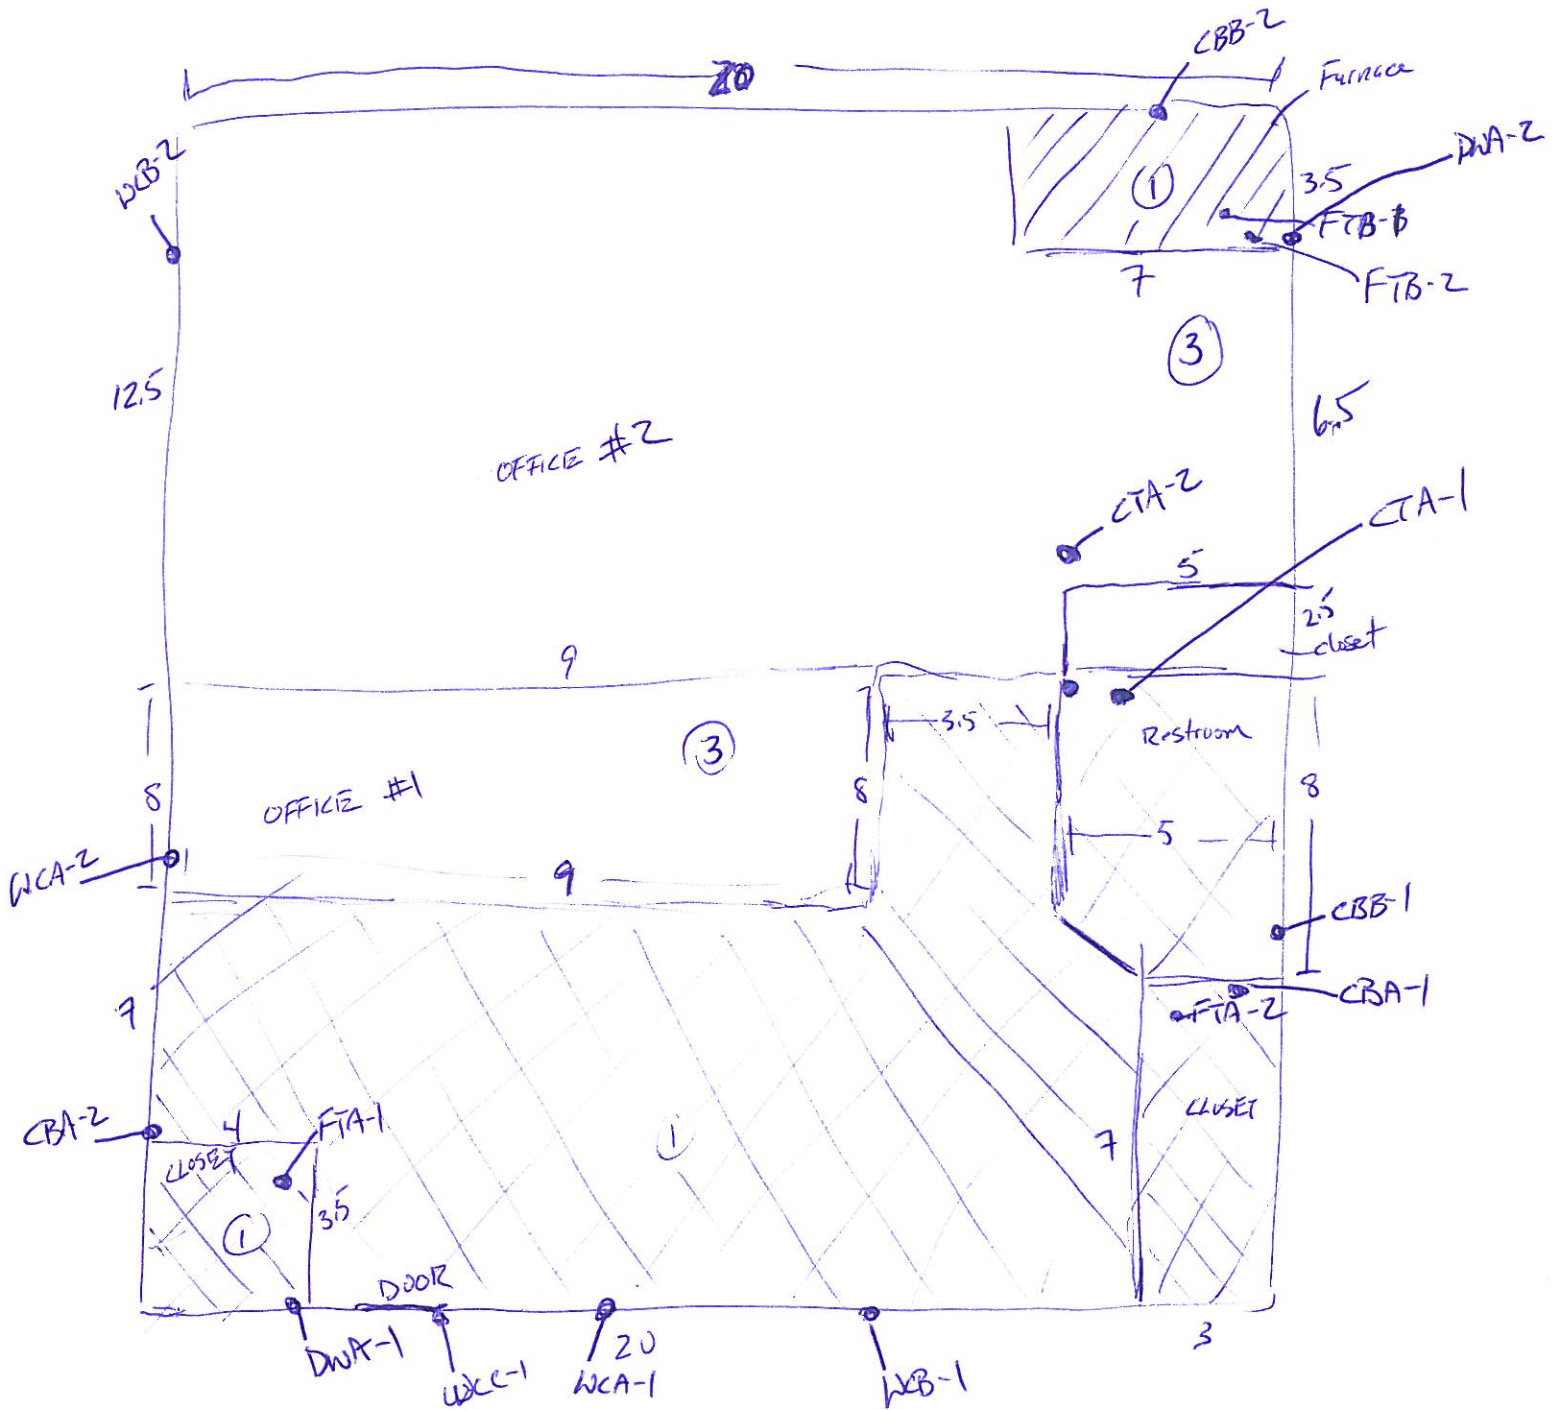
Oak View Court

Popcorn ceiling texture throughout
8 ft ceiling

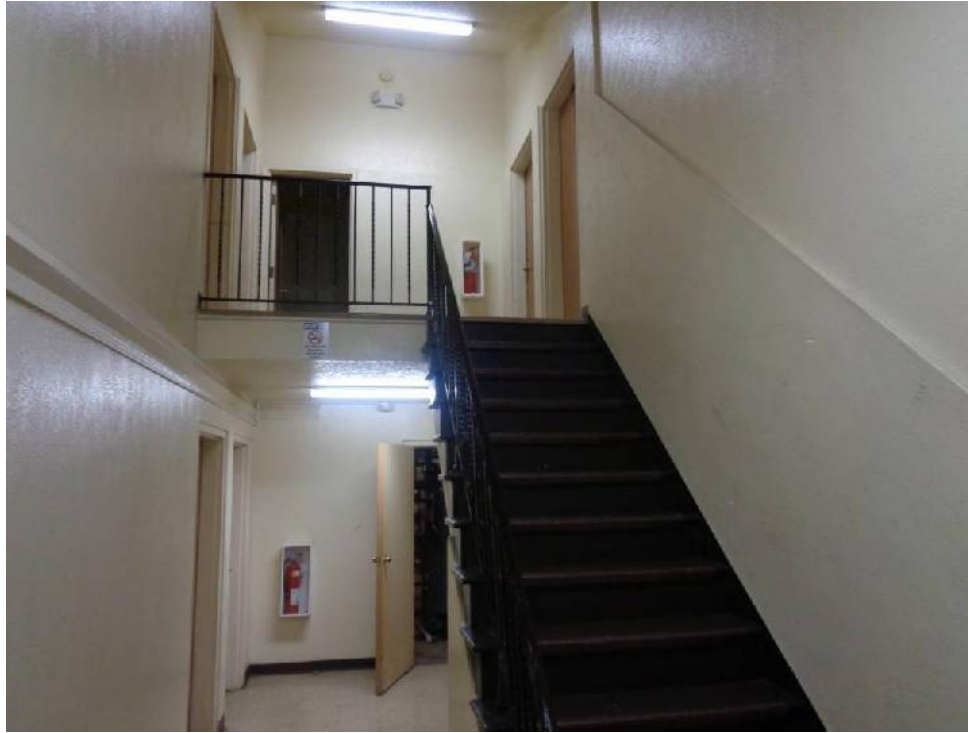
Photo 5: View of common area hallway showing first floor beige floor tile (FTA, non-asbestos) and drywall (DWB, non-asbestos) of 345 Oak View Court.

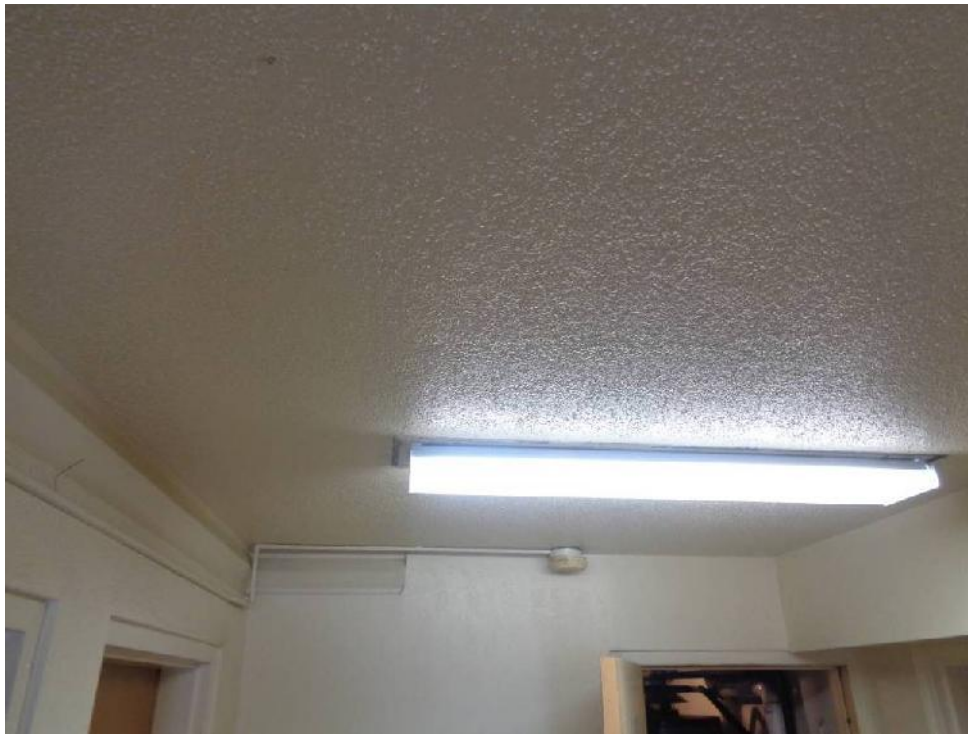
Photo 6: View of ceiling texture (CTA, non-asbestos) in common area hallways in 345 Oak View Court.

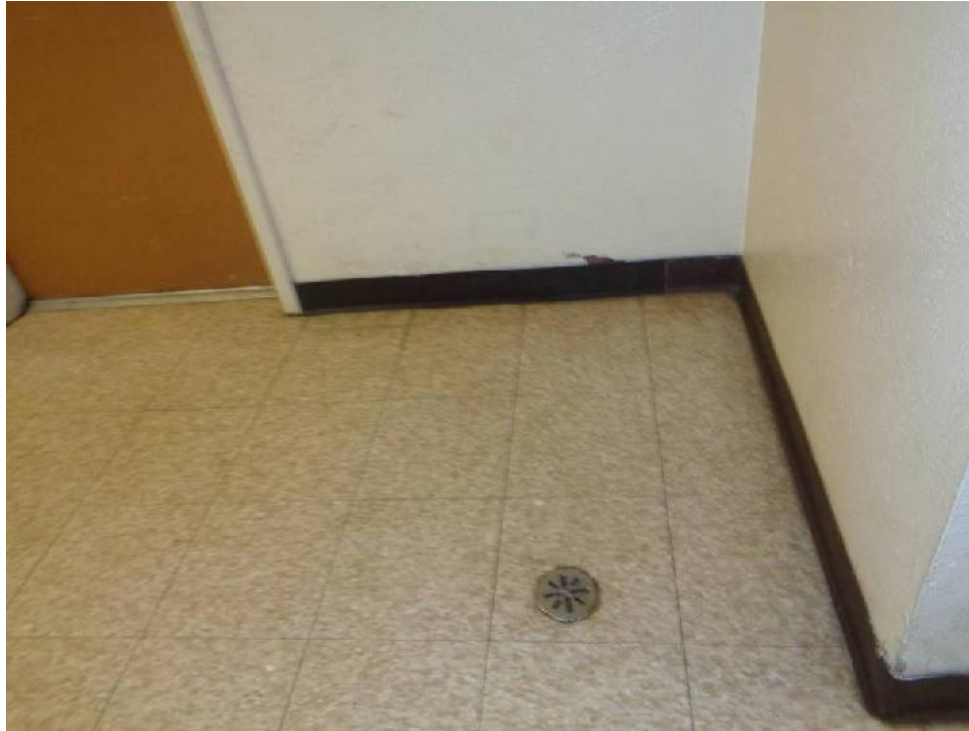
Photo 7: Typical view of brown cove base (BCA, non-asbestos) found throughout the facility common areas.

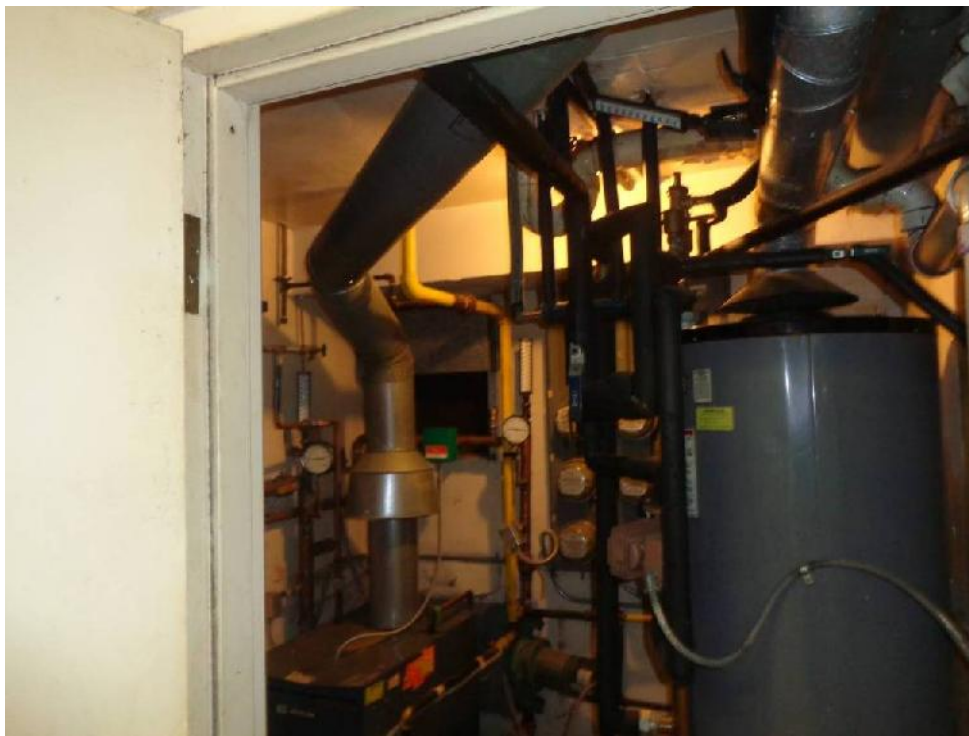
Photo 8: Typical view of common area boiler room showing drywall in the boiler room and hallway (DWA/DWB, non-asbestos).

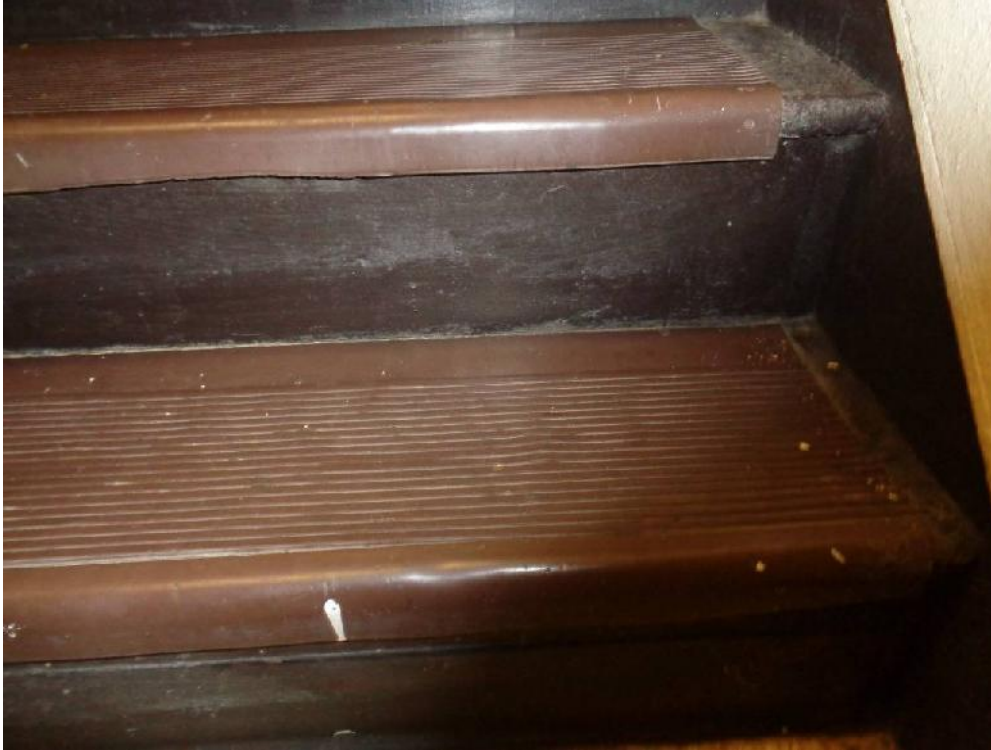
Photo 9: Typical view of brown stair tread (STA, non-asbestos) found throughout facility common areas.

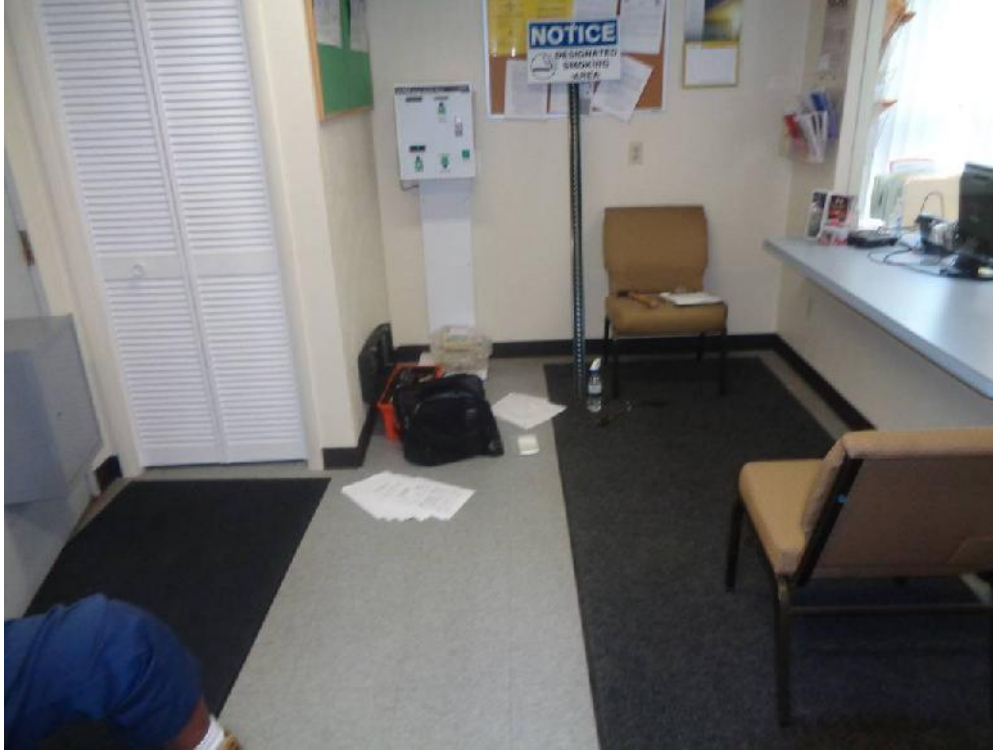
Photo 11: View of gray floor tile (FTA, mastic is asbestos containing), brown cove base (CBA, non-asbestos), and drywall (DWA, non-asbestos) in the entryway of the office building.

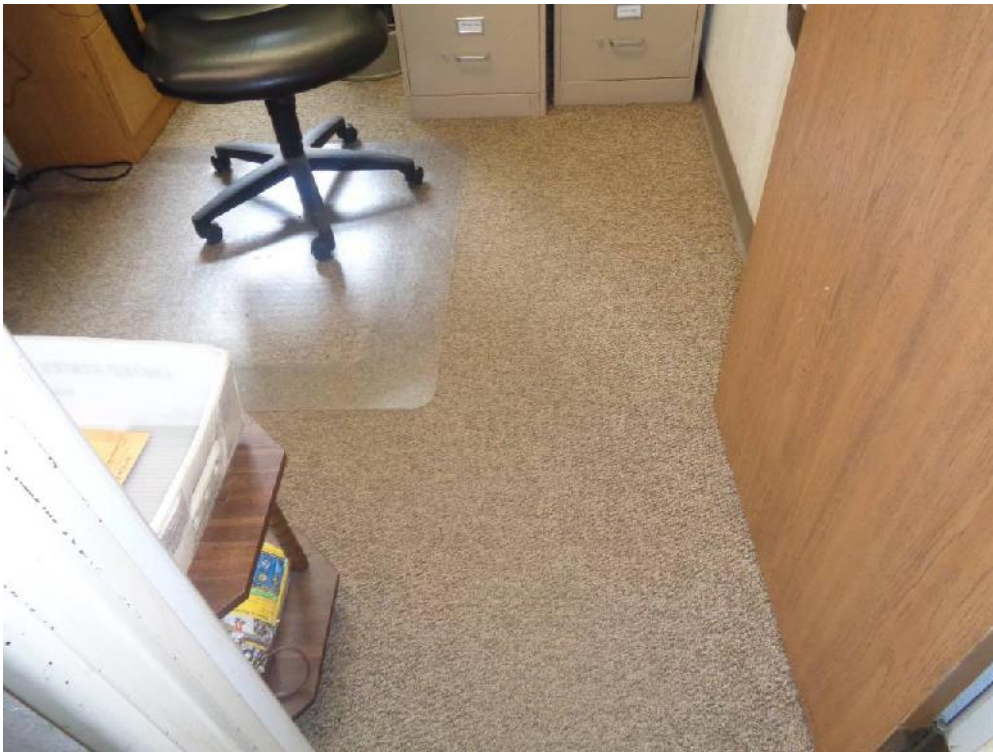
Photo 12: View of carpet and gray cove base (CBA, non-asbestos) in office building.

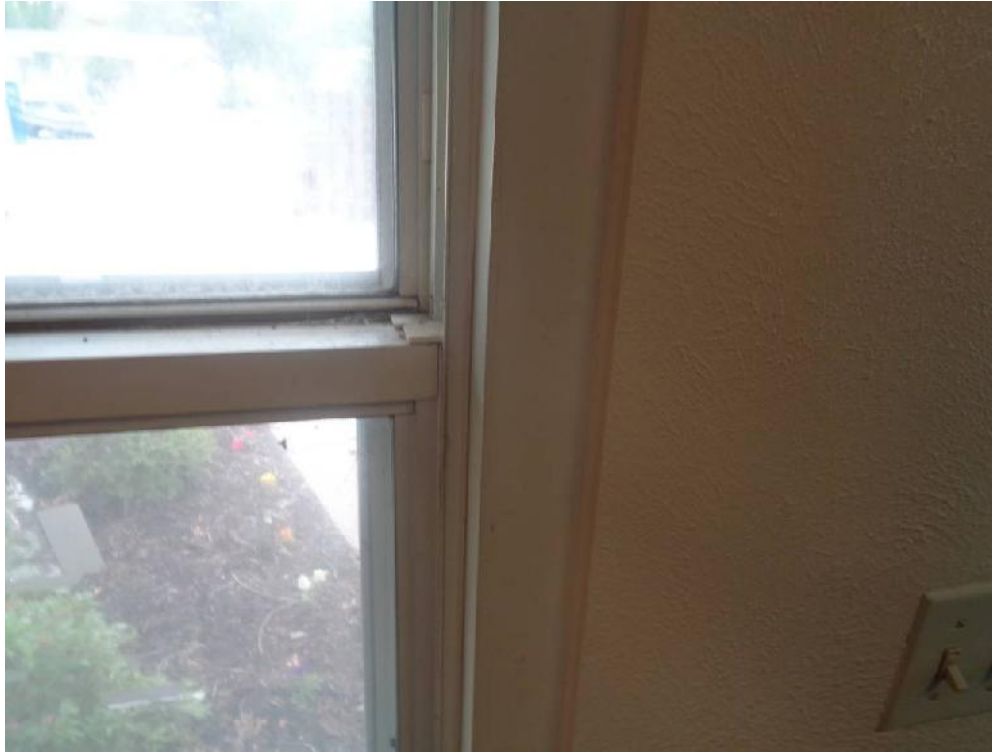
Photo 13: Typical view of interior white window caulk (WCA, non-asbestos) found throughout the facility.

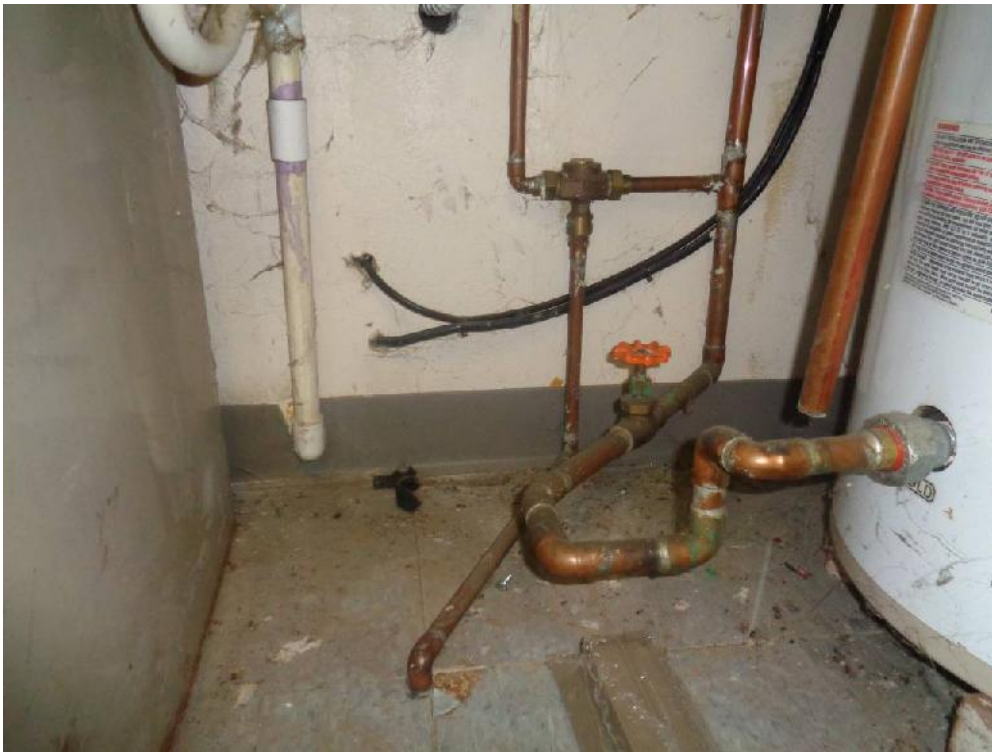
Photo 14: View of gray floor tile (FTB, non-asbestos) in the furnace room of Oak View Office.

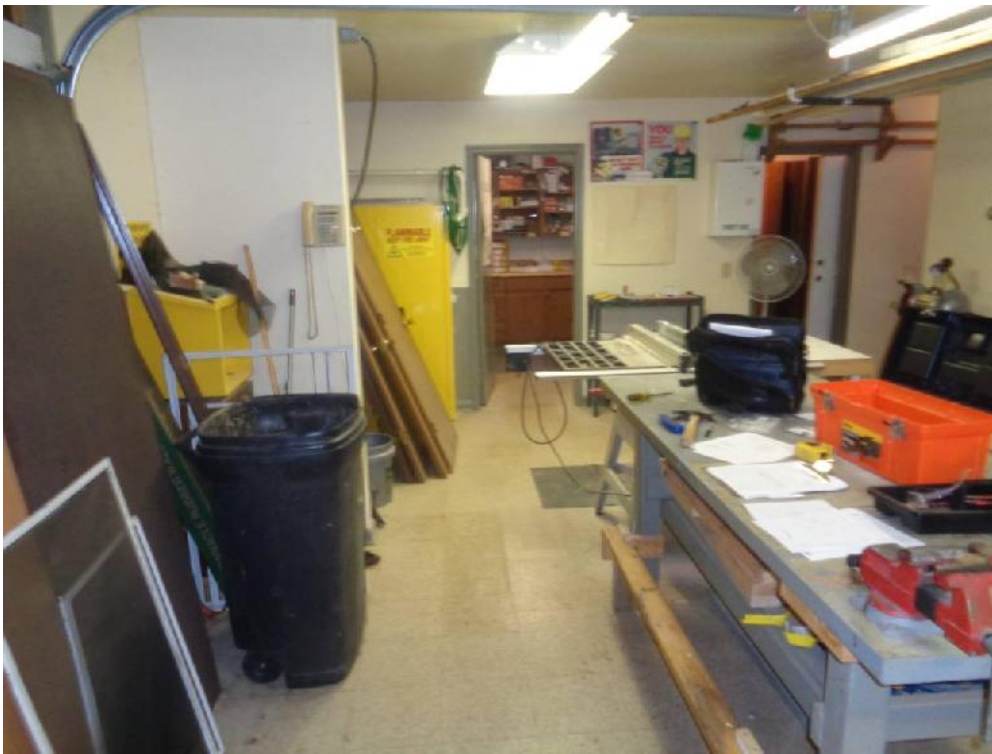
Photo 16: View of beige floor tile (FTA, mastic is asbestos containing) found throughout the Oak View Court maintenance building.

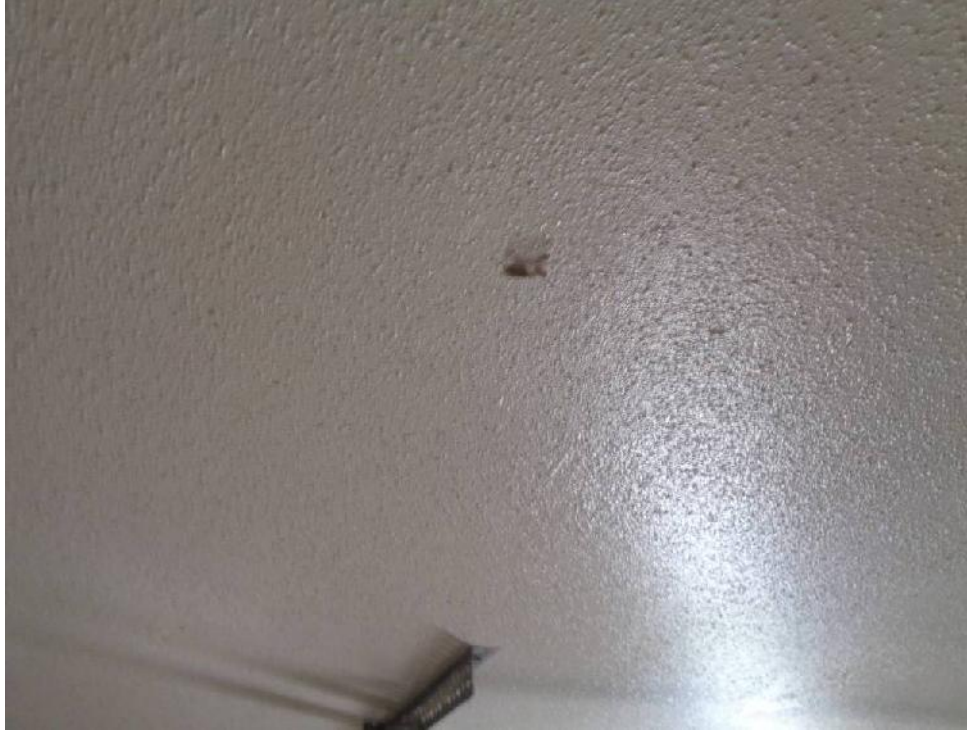
Photo 17: View of white ceiling texture (CTA, asbestos containing) found throughout the Oak View Court maintenance building.

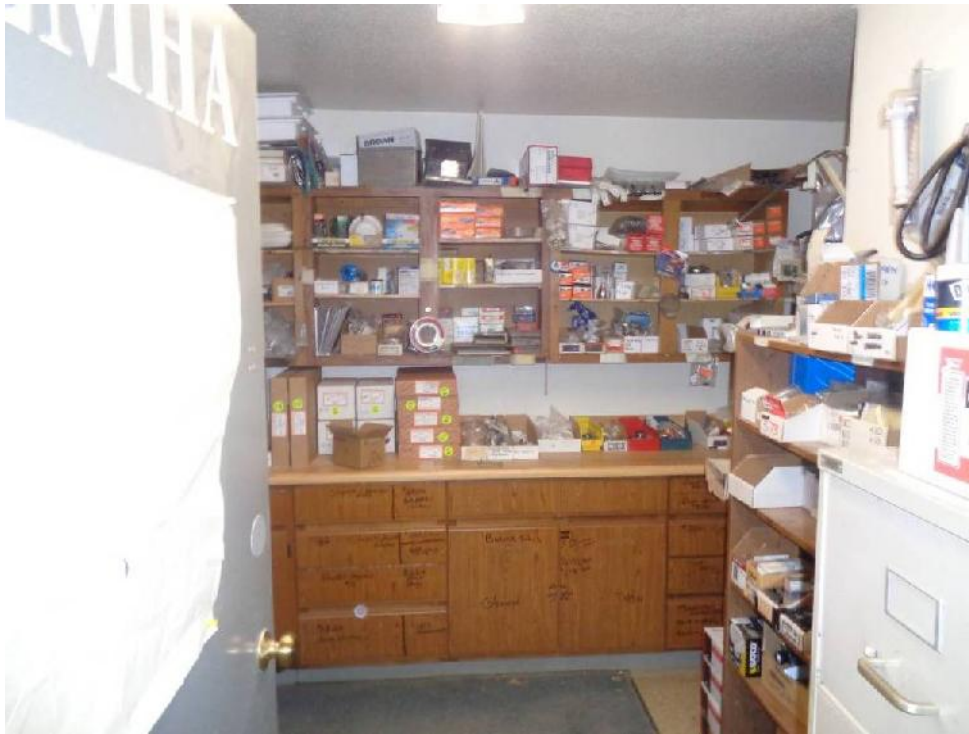
Photo 18: View of gray cove base (BCB, non-asbestos) from the storage rooms of the Oak View Court maintenance building.

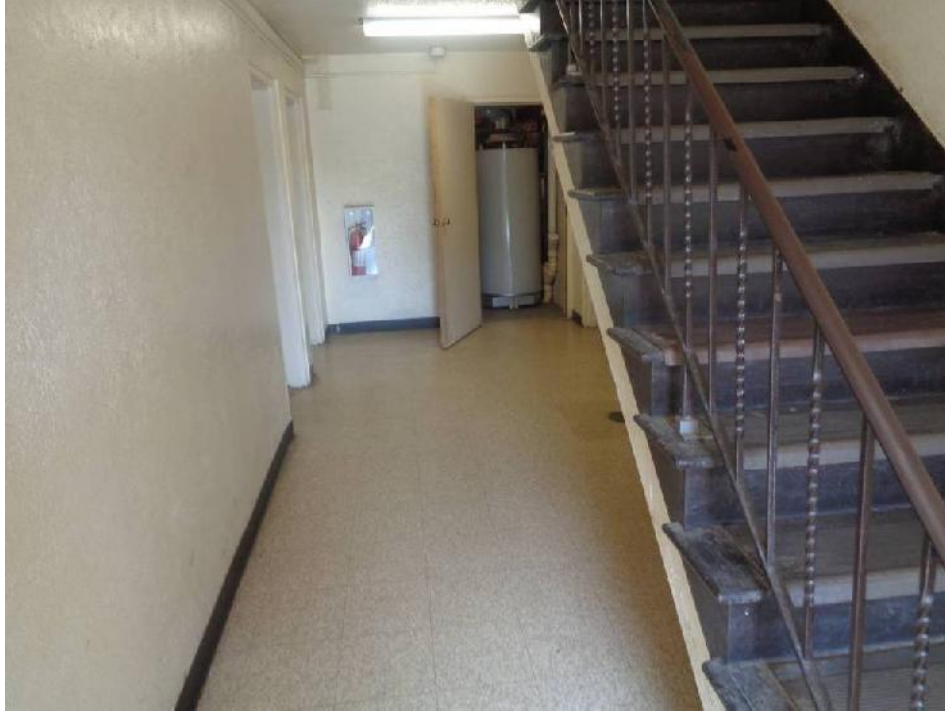
Photo 19: View of beige floor tile (FTA, mastic is asbestos containing), brown stair tread (STA, non-asbestos), drywall (DWA, non-asbestos), and black cove base (BCA, non-asbestos) from the common areas of 9842 Oak Place Court.

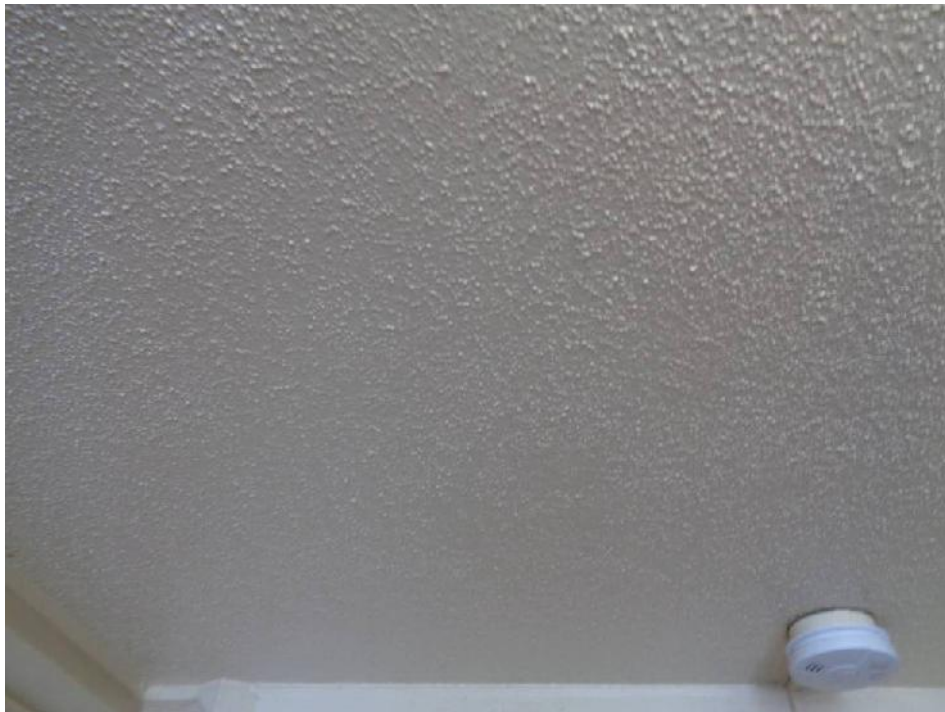
Photo 20: View white ceiling texture (CTA, asbestos containing) from the common areas of 9842 Oak Place Court.

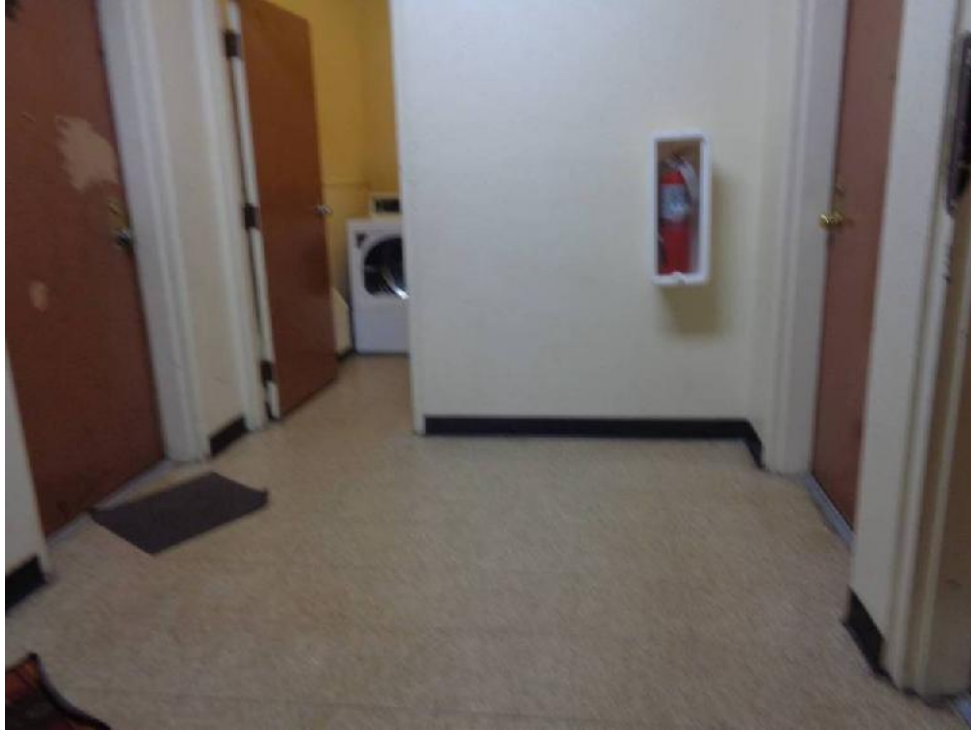
Photo 21: View of beige floor tile (FTA, non-asbestos) from the second floor hallway and laundry room of 9845 Oak Place Court common area.

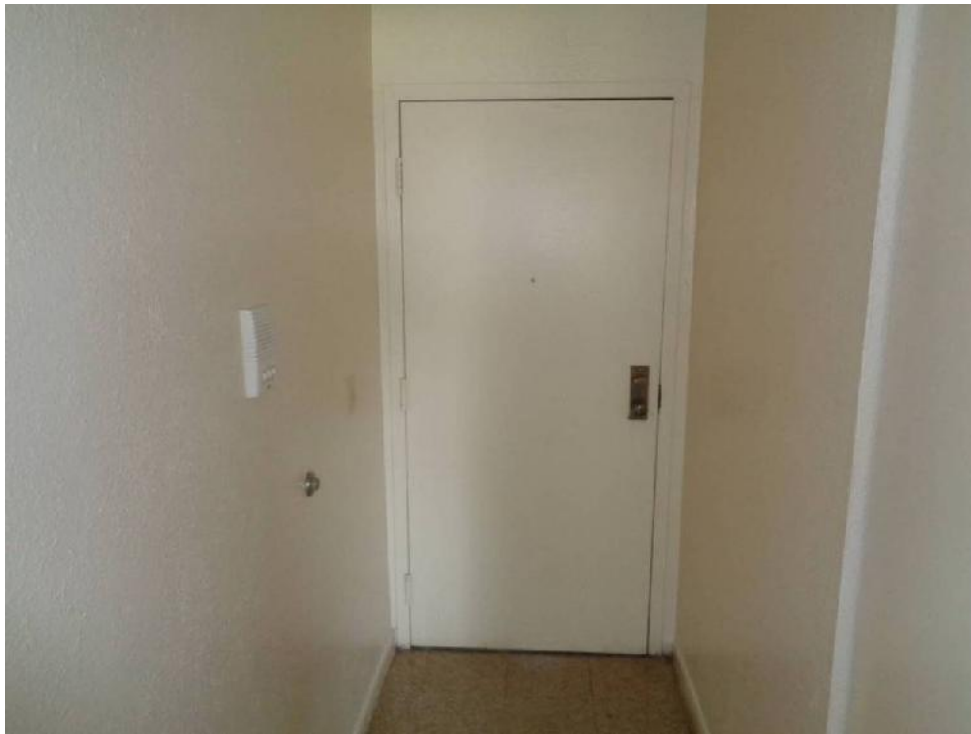
Photo 22: View of entry door and drywall (DWA, non-asbestos) from Unit C of 9842 Oak Place Court.

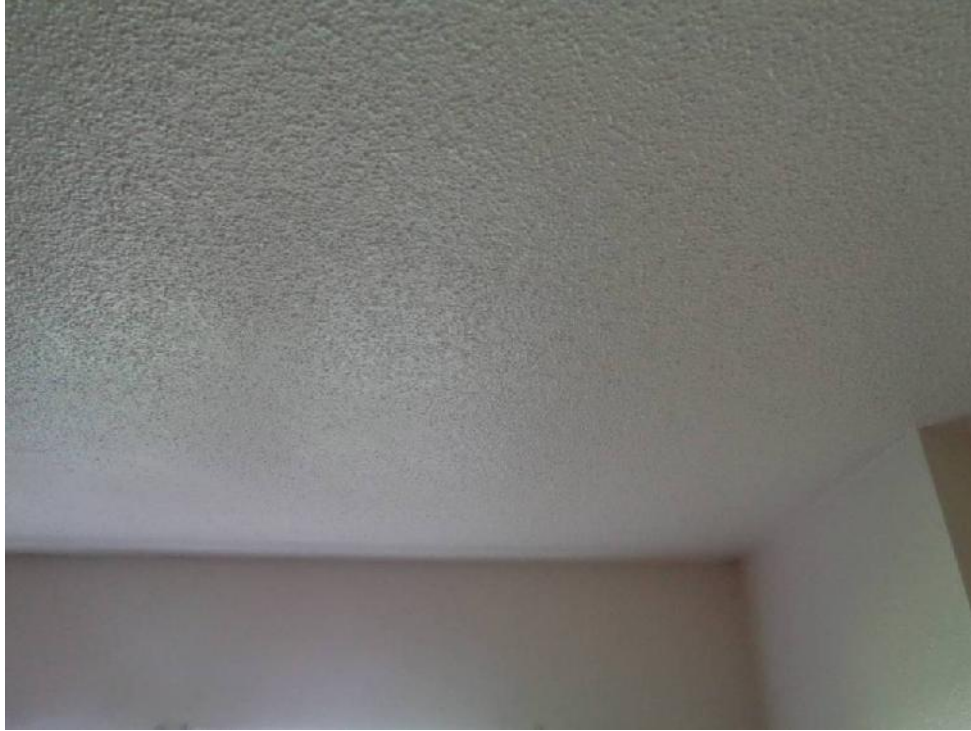
Photo 23: View of white ceiling texture (CTA, asbestos containing) from Unit C of 9842 Oak Place Court.

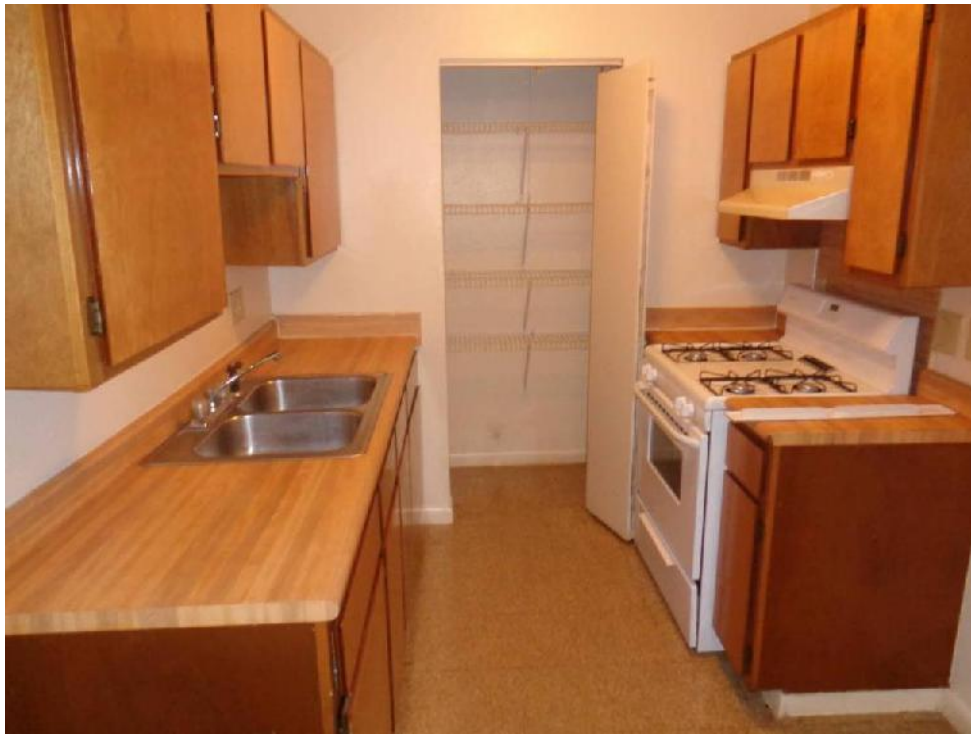
Photo 24: View of beige floor tile (FTB, mastic is asbestos containing) from the kitchen of Unit C of 9842 Oak Place Court.

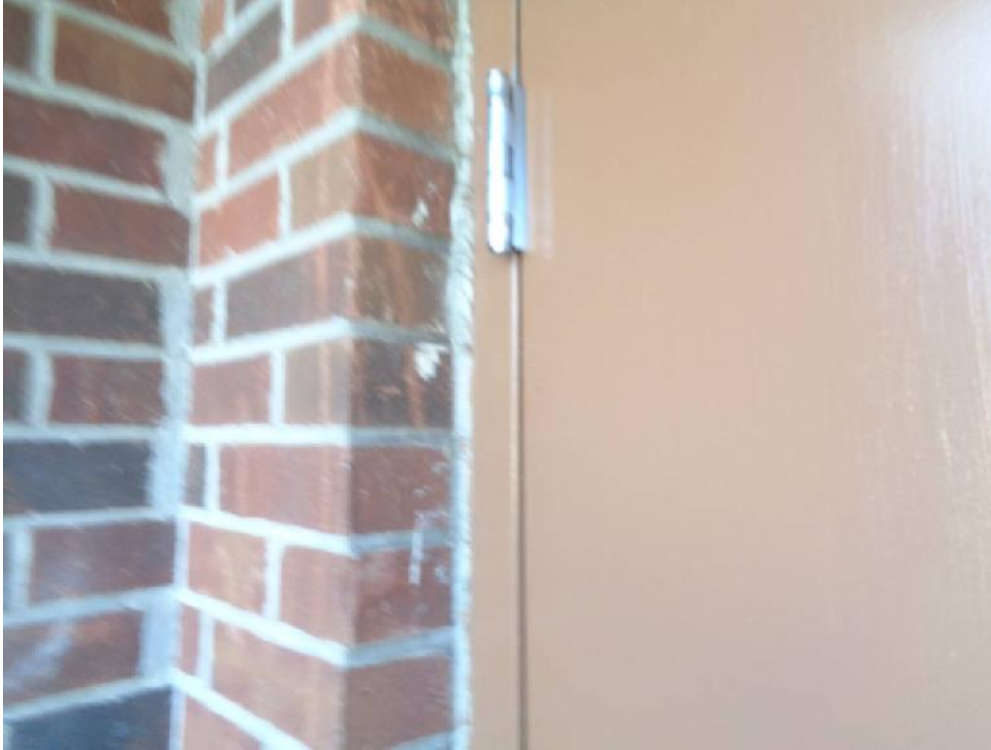
Photo 25: Typical view of white door caulk (DCA, non-asbestos) of the exterior doors.

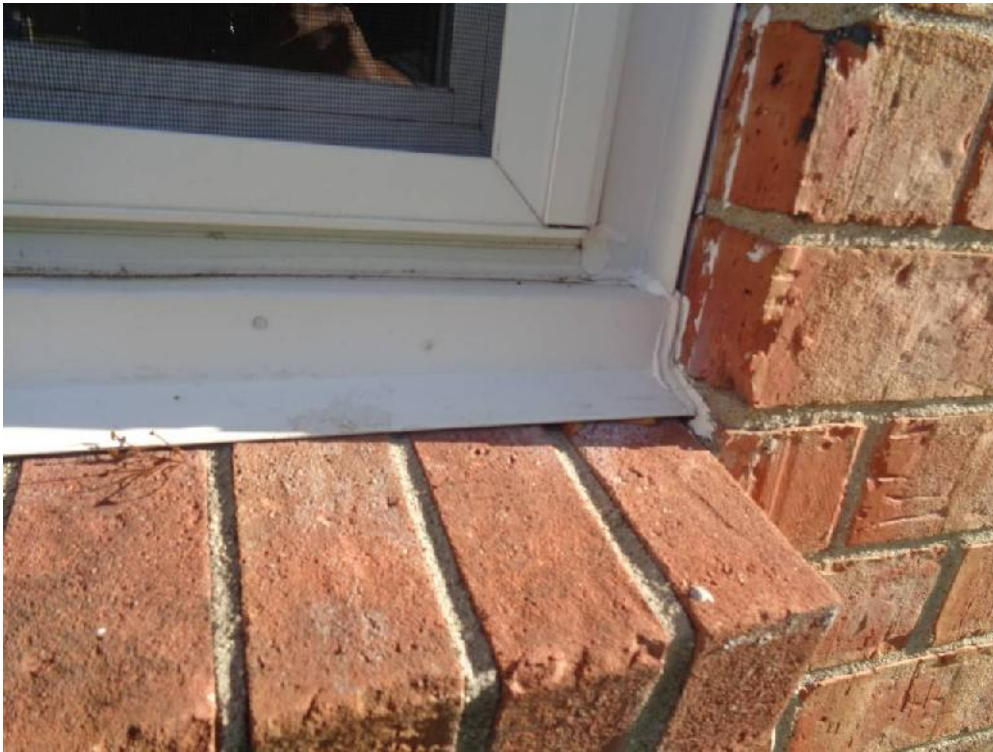
Photo 26: Typical view of white window caulk (WCA, non-asbestos) of the exterior windows.
