**ASBESTOS SURVEY  
PARKSIDE INN PROPERTY  
1415 WEST OLIVE AVENUE  
FRESNO, CALIFORNIA**

Project No. 014-20124  
September 1, 2020

Prepared by:  
Krazan & Associates, Inc.  
215 West Dakota Avenue  
Clovis, California 93612  
(559) 348-2200

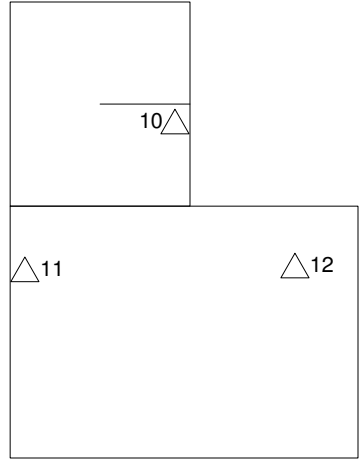
Rm 214

11	Texture	motel	214	ND	NC	NA	homogenous throughout
<b>12</b>	<b>Sprayed-on acoustic</b>	<b>motel</b>	<b>214</b>	<b>4%</b>	<b>210</b>	<b>G/FR</b>	<b>homogenous throughout</b>
13	Gypsum board / taping material	motel	217	ND	NC	NA	homogenous throughout
14	Texture	motel	217	ND	NC	NA	homogenous throughout
<b>15</b>	<b>Sprayed-on acoustic</b>	<b>motel</b>	<b>217</b>	<b>4%</b>	<b>210</b>	<b>G/FR</b>	<b>homogenous throughout</b>
16	Gypsum board / taping material	motel	219	ND	NC	NA	homogenous throughout
17	Texture	motel	219	ND	NC	NA	homogenous throughout
<b>18</b>	<b>Sprayed-on acoustic</b>	<b>motel</b>	<b>219</b>	<b>4%</b>	<b>210</b>	<b>G/FR</b>	<b>homogenous throughout</b>
19	Gypsum board / taping material	motel	212	ND	NC	NA	homogenous throughout
20	Texture	motel	212	ND	NC	NA	homogenous throughout
<b>21</b>	<b>Sprayed-on acoustic</b>	<b>motel</b>	<b>212</b>	<b>4%</b>	<b>210</b>	<b>G/FR</b>	<b>homogenous throughout</b>

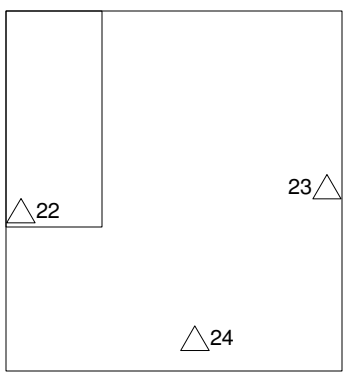
Rm 232

22	Gypsum board / taping material	motel	232	ND	NC	NA	homogenous throughout
23	Texture	motel	232	ND	NC	NA	homogenous throughout
<b>24</b>	<b>Sprayed-on acoustic</b>	<b>motel</b>	<b>232</b>	<b>2%</b>	<b>210</b>	<b>G/FR</b>	<b>homogenous throughout</b>
25	Gypsum board / taping material	motel	241	ND	NC	NA	homogenous throughout
26	Texture	motel	241	ND	NC	NA	homogenous throughout
<b>27</b>	<b>Sprayed-on acoustic</b>	<b>motel</b>	<b>241</b>	<b>4%</b>	<b>210</b>	<b>G/FR</b>	<b>homogenous throughout</b>
28	Gypsum board / taping material	motel	243	ND	NC	NA	homogenous throughout
29	Texture	motel	243	ND	NC	NA	homogenous throughout
<b>30</b>	<b>Sprayed-on acoustic</b>	<b>motel</b>	<b>243</b>	<b>4%</b>	<b>210</b>	<b>G/FR</b>	<b>homogenous throughout</b>
31	Gypsum board / taping material	motel	252	ND	NC	NA	homogenous throughout
