LIMITED-SCOPE ASBESTOS SURVEY REPORT

**Minneapolis Public Housing Authority
630 Cedar Avenue South, Cedar Hi Apts
Minneapolis, Minnesota**

Angstrom No.00-0616

June 16th, 2000

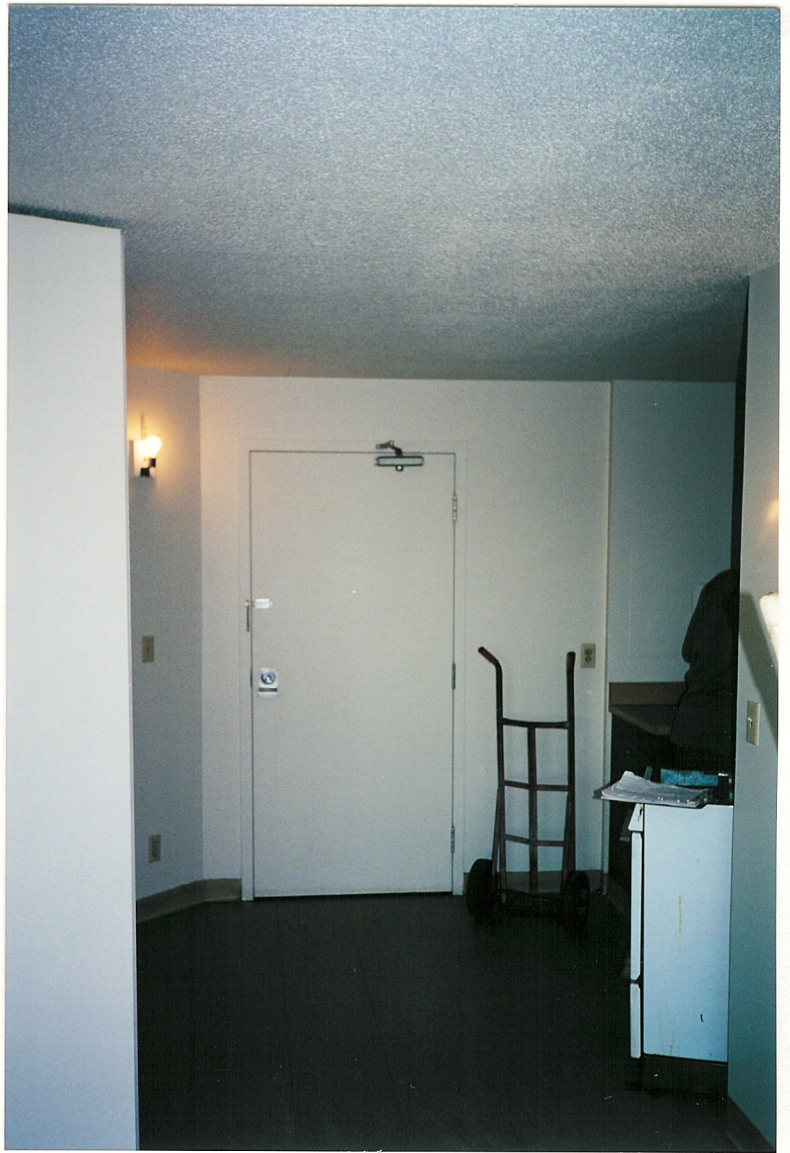
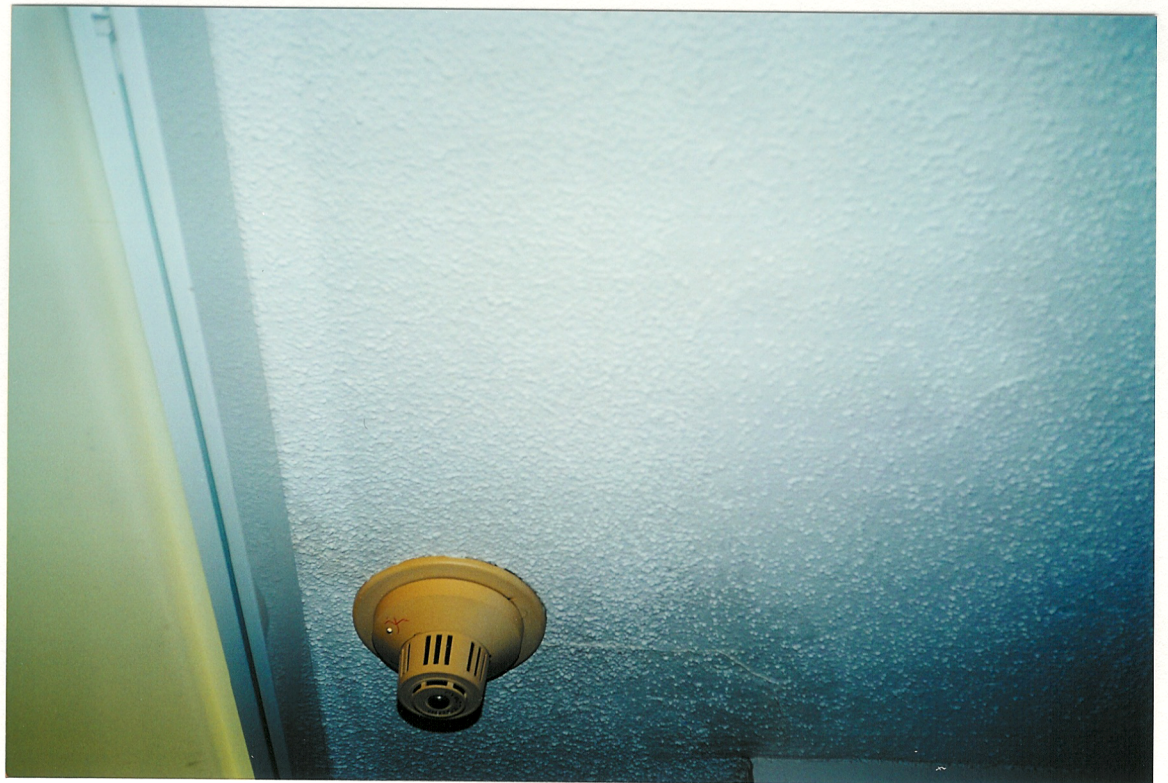
- Approximately 500 to 600 square feet of white ceiling texture in each dwelling unit in generally good condition.
- Approximately 550 to 600 square feet of white ceiling texture in each of the upper twenty five corridors in generally good condition.
- Approximately 900 to 1,000 square feet of white ceiling texture in the north office area of the basement in generally good condition.

Plates 1 & 2: Showing the ceiling texture (ACM) in Apt. # 907 and on the 25th floor corridor in 630 Cedar Avenue, Minneapolis.

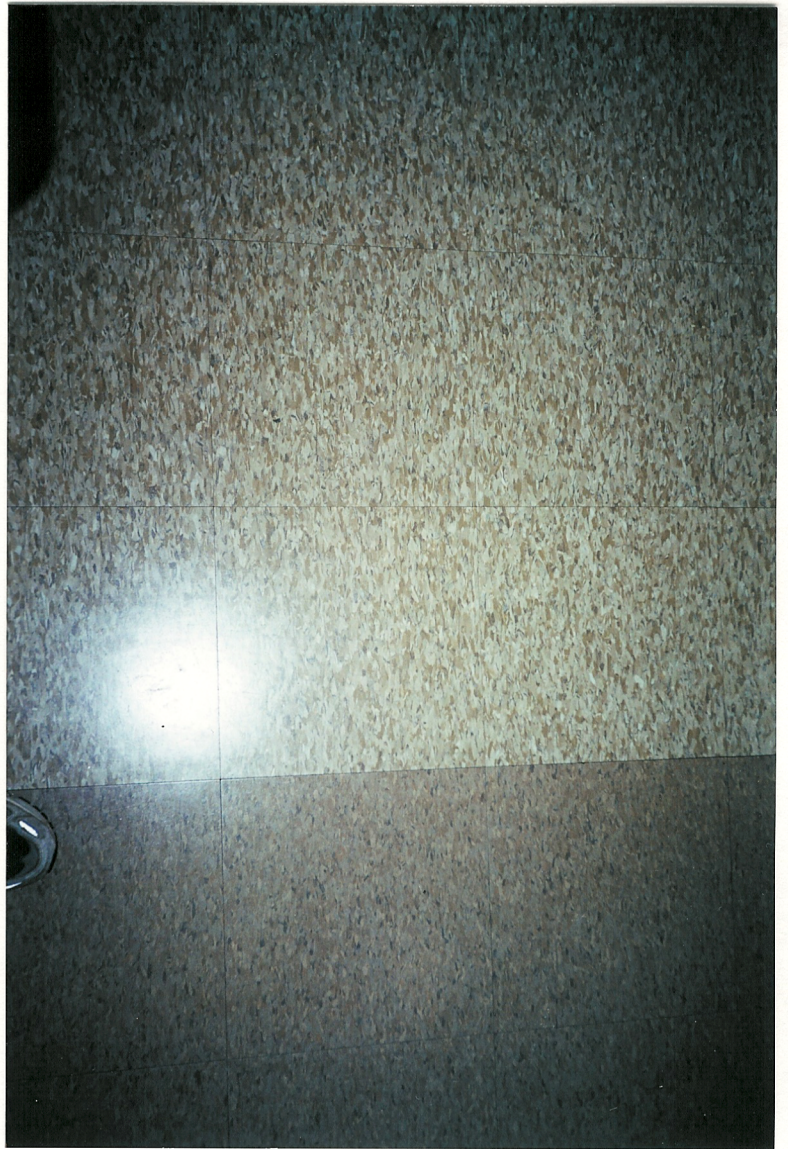
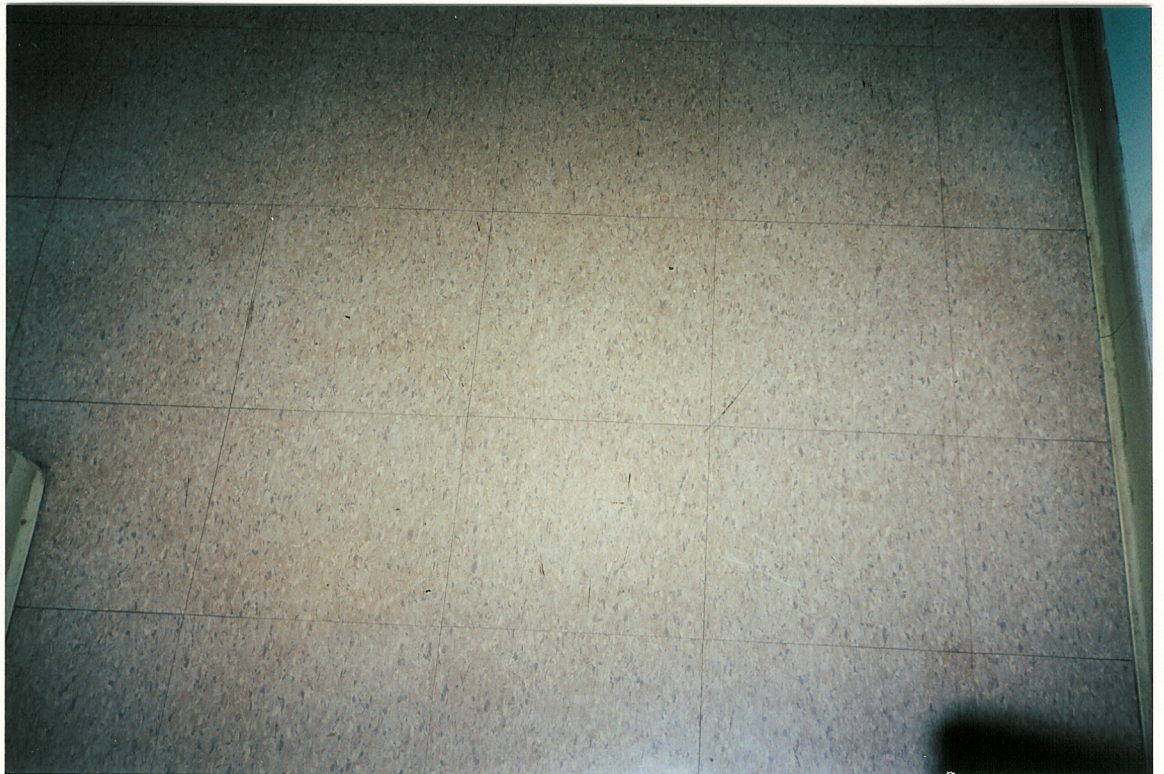
- Approximately 525 to 575 square feet of black floor tile mastic beneath non-ACM 12"x12" floor tiles in each apartment. Mastic appears to be in generally good condition.

- Approximately 550 to 600 square feet of 12"x12" tan floor tiles plus the associated black floor tile mastic in each of the upper twenty-five corridors. Floor tiles and mastics were found to be in generally good condition.
- Approximately 20 to 25 square feet of 12"x12" floor tiles with associated black mastic in the Main floor Janitor's Closet in generally fair condition.

Plates 3 & 4: Showing the
12" x 12" floor tile and
mastic (ACM) - typical
throughout.
